# Fifth Creek Survey and Management Plan

Report to the Campbelltown City Council

**Prepared by Catherine Miles** Miles Environmental Pty Ltd March 2017

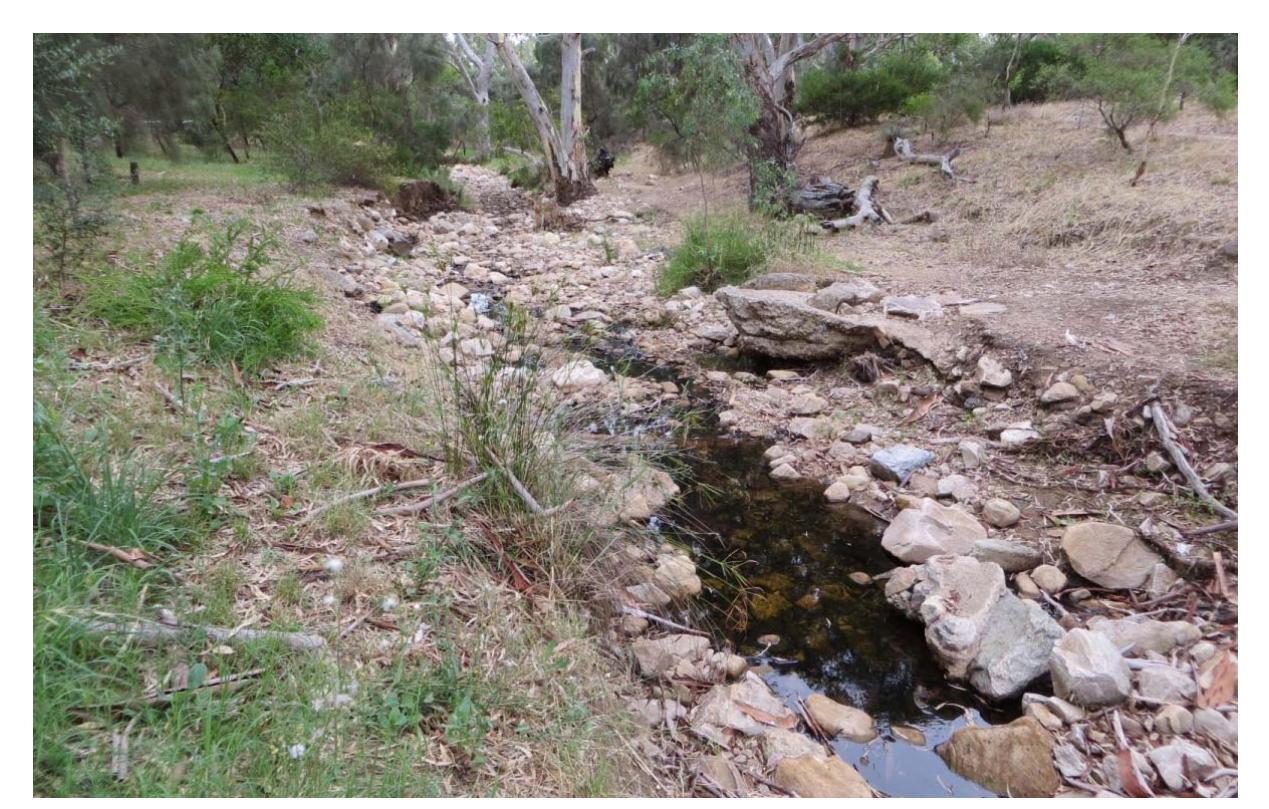
Figure 1 Water was present in deeper pools, note broken concrete structure on the right creek bank

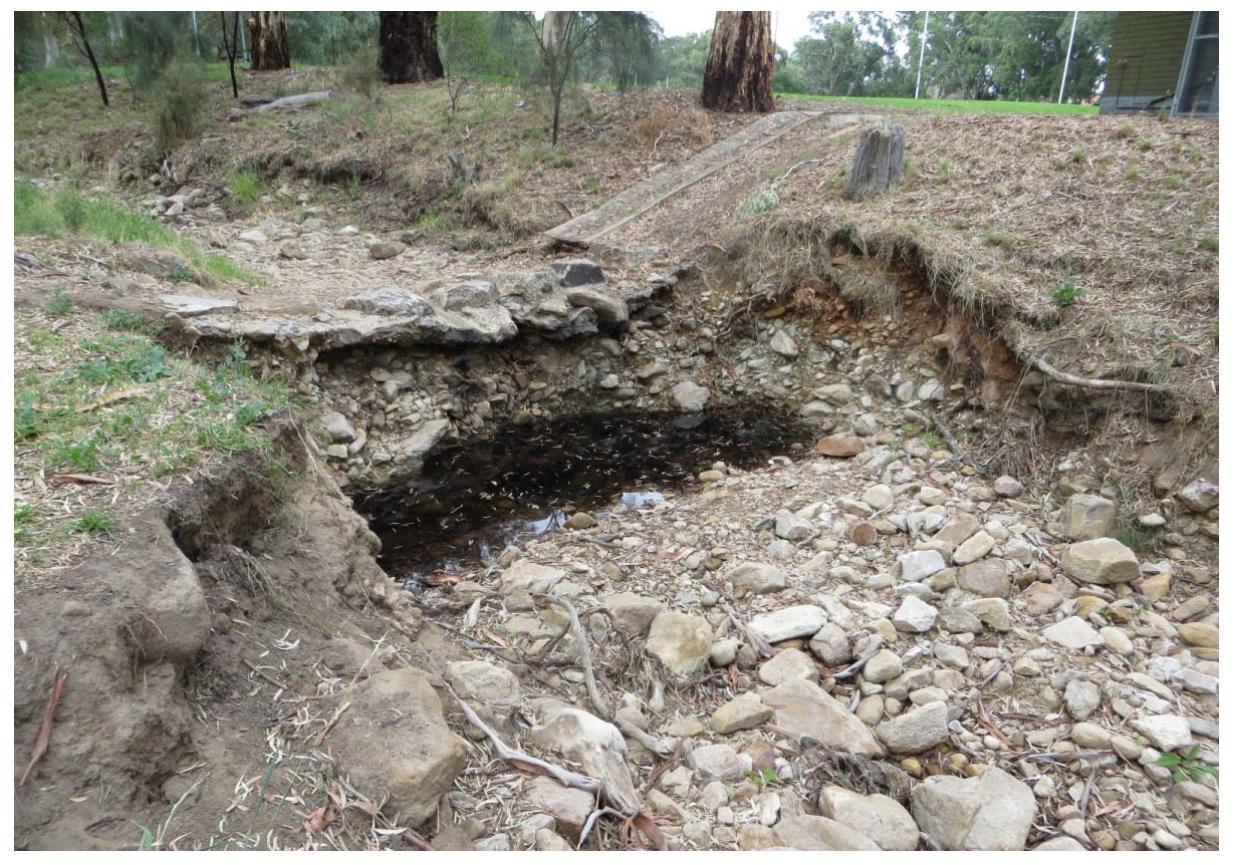
Figure 2 The scour pool and some bank erosion behind the sports club rooms

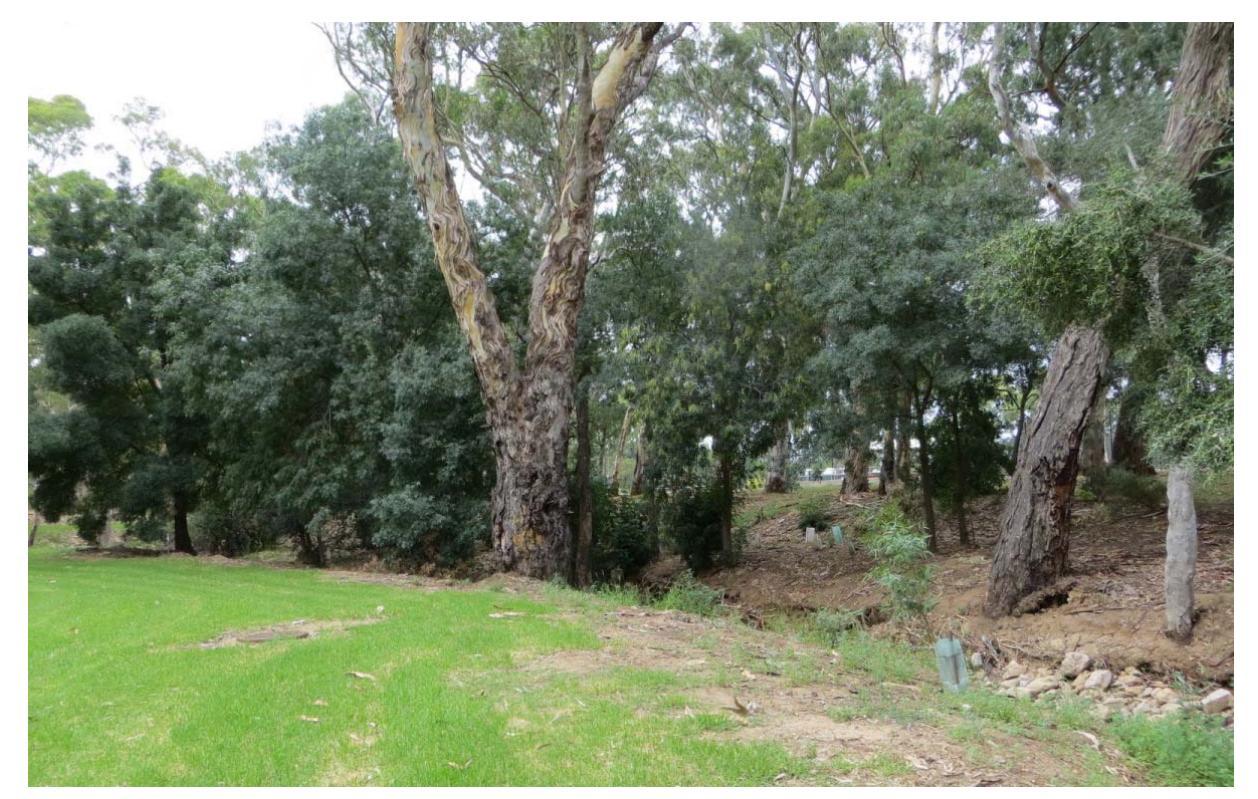
Figure 3 Remnant River Red Gums over Ash and Olive trees

Removal of the Olive and Ash trees and other high threat weeds in the upstream (medium condition) part of the watercourse is recommended as a priority for Section 2 as it will reduce the weed threat to the adjacent revegetation area and enable the revegetation to be extended into this area, linking with the Wadmore Park / Pulyonna Wirra. Weed control in the lower end should focus firstly on ensuring the weeds do not spread into the revegetation area. Removal of the weeds should be undertaken in the longer term, working from upstream to downstream, to reduce the weed threat to downstream areas.

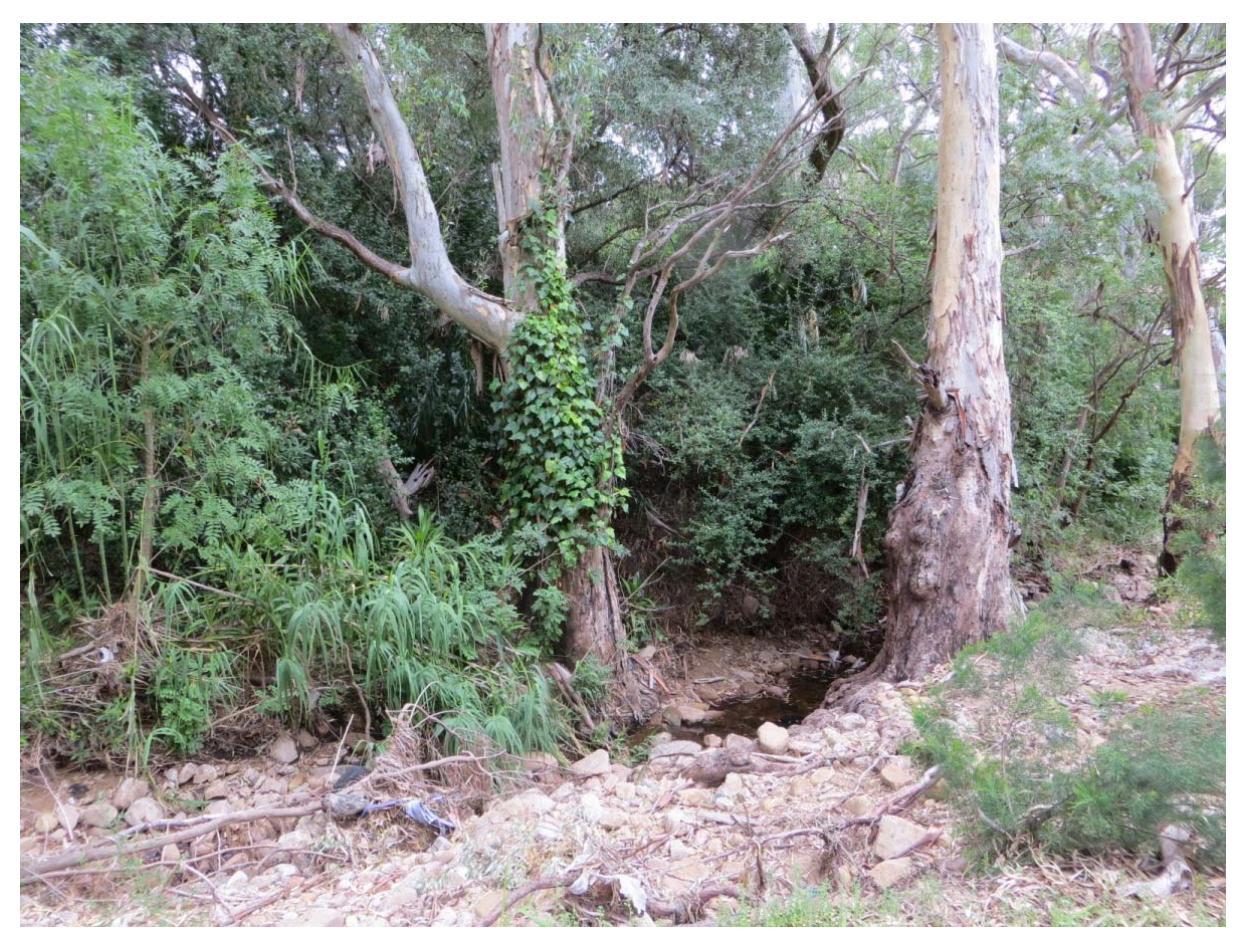
Figure 5 The downstream end of Section 2 is overgrown with exotic species

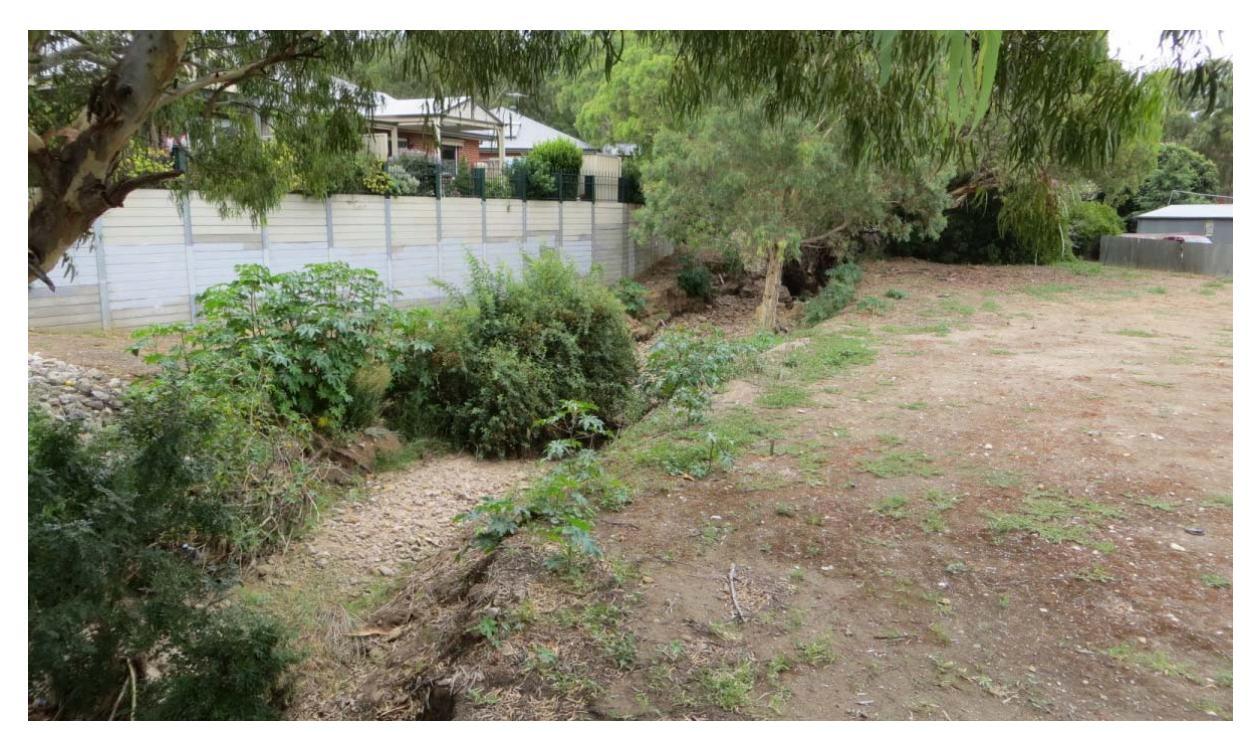
High threat weeds	High threat weeds are most abundant upstream of Gorge Road, particularly Castor Oil Plant. Non-local natives Golden Wreath Wattle and Swamp Oak are re-growing where they have been cut back, other non-local natives are Flinders Ranges Wattle and Bracelet Honey Myrtle. Few Olives, Ash, Palms, Giant Reed and Italian Buckthorn. Occasional Nasturtiums, Rice Millet and South African Daisy.
Habitat (terrestrial)	Large trees (although fewer than upstream areas), some with hollows, leaf litter, large shrubs.
Habitat (watercourse)	Rocky creek bed
Watercourse erosion	Bed deepening above Gorge Road. Recent bank erosion downstream of the gabions below Schulze Road bridge has exposed buried pipes.
Channel modification	Appears to be unmodified except for some reinforcing of the banks with gabions

Figure 6 Looking upstream from Gorge Road, note Castor Oil Plants growing on the banks

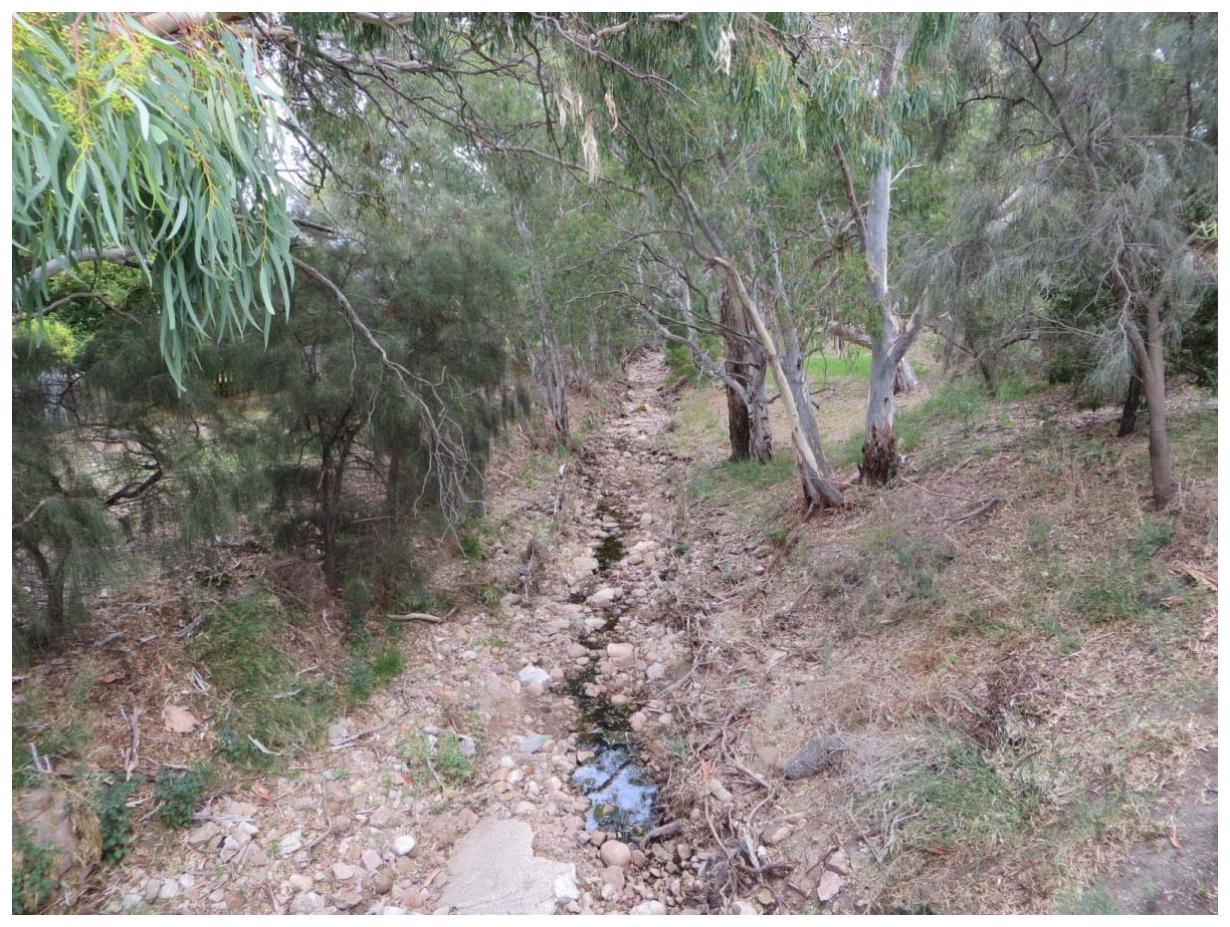
Most of this section was in moderate condition, with a relatively undisturbed creek channel, an overstorey of remnant River Red Gums and scattered plantings of local native shrub and small tree species (Figure 7). There are high threat weeds throughout but rarely in high abundance. There is a wide riparian reserve along most of the length with potential for further revegetation focussing on lower growing species. The Chain of Trails Master Plan (COTMP, Swanbury Penglase 2014) proposes the eastern bank adjacent to Woodlands Road and the banks adjacent to Stoneybrooke Drive as areas for improving biodiversity. These sites have good potential although the latter will require removal of non-local native species. The banks are currently sprayed along most of the length and therefore any revegetation of the banks will require some changes to the current management regime.

Figure 7 Downstream of Gorge Road

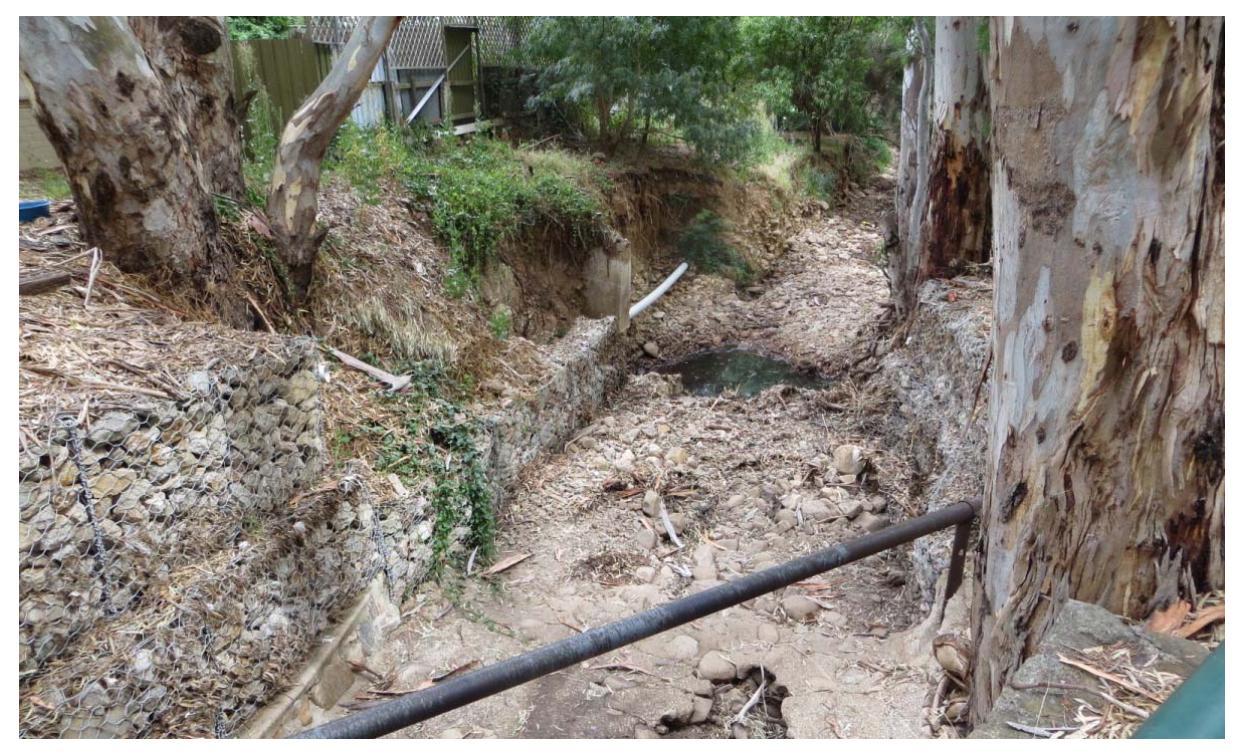
There is some minor erosion, the most severe of which is upstream of Gorge Road and downstream of Schulze Road (Figure 8).

Figure 8 Erosion downstream of Schulze Road

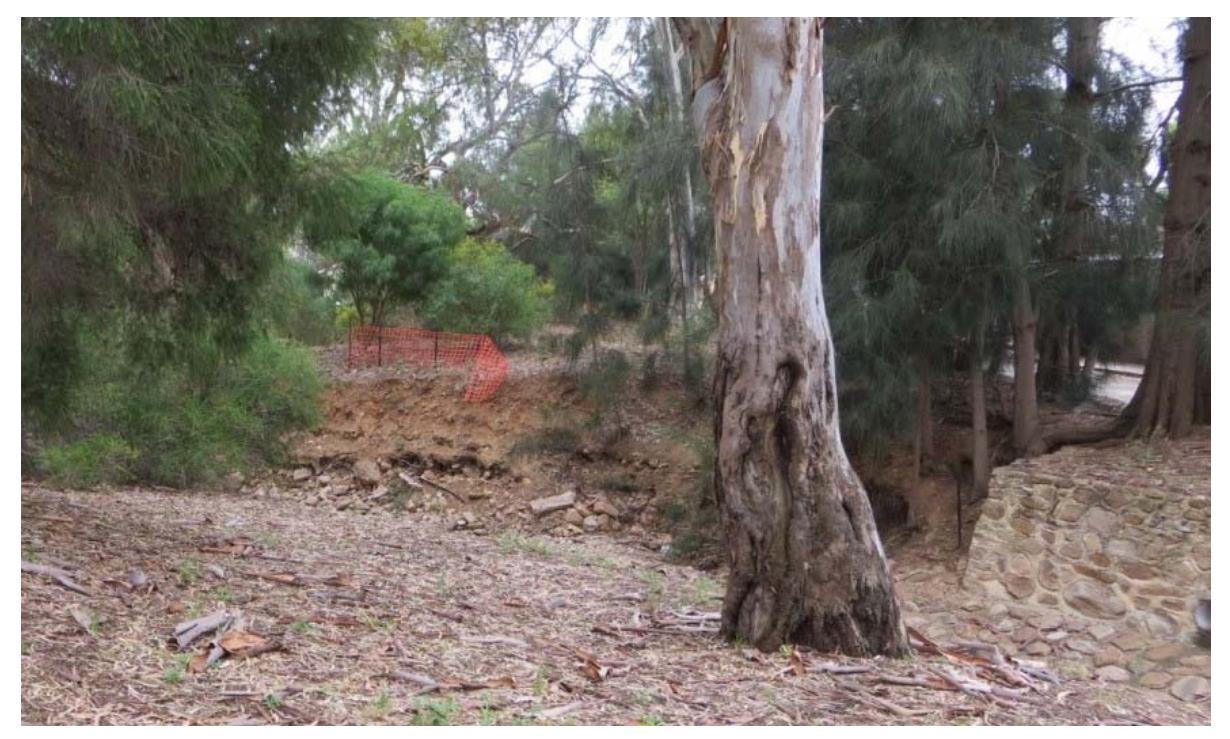
The creek appears to have sustained some erosion damage from the floods last year. This erosion is generally minor except for areas downstream of the floodway, particularly near to the football clubrooms where the banks are close to the building (Figure 10). Engineering advice will be required to determine which areas require works to stabilise them and what should be done,

Figure 10 Erosion downstream of the football club rooms, note the Casuarina's suckering on the far bank and revegetation in the background

however the planting of local native sedges, rushes and grasses around any new (and existing) structures will help to stabilise them.

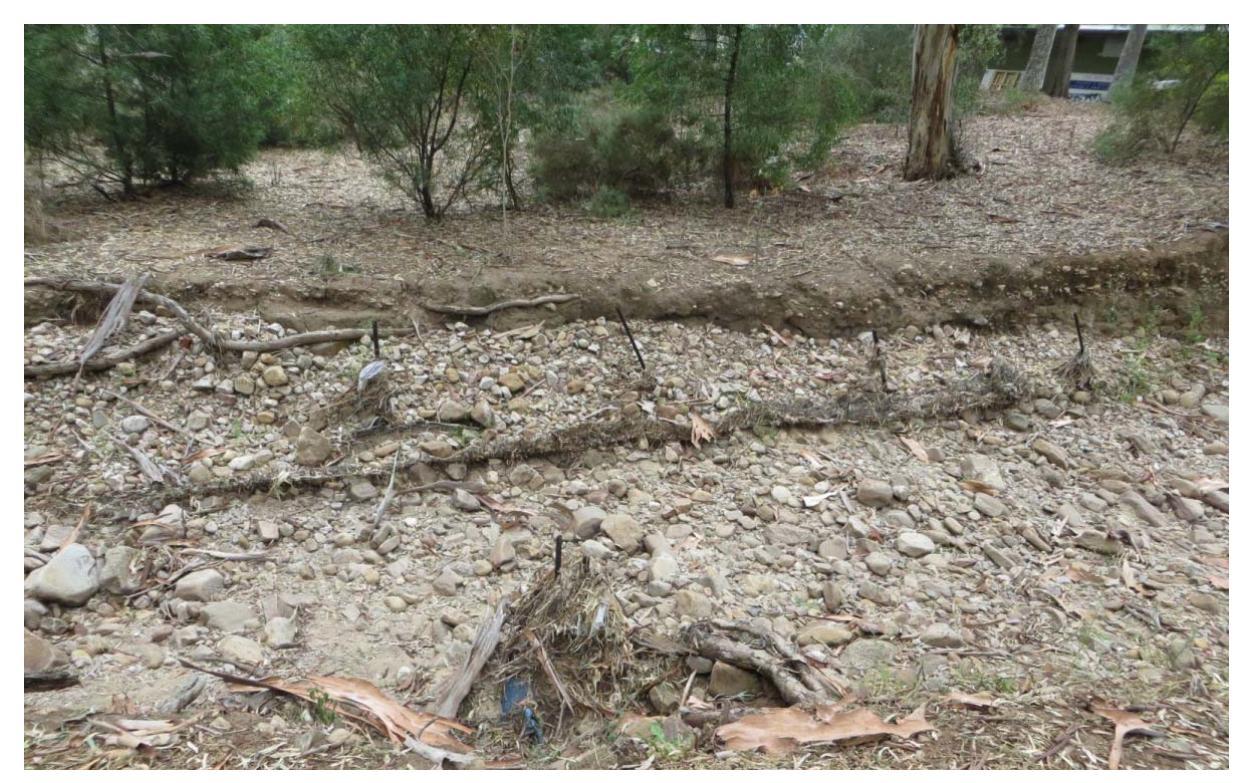
There are existing erosion control structures in the watercourse. Most of these appear to have functioned successfully in the recent floods but some are collapsing and may need to be removed and replaced, according to an engineer's advice. At one location a small erosion control 'fence' has been used to trap rocks against the bank and prevent bank erosion (Figure 11below). It has functioned effectively but has been partly pushed over and the droppers may pose a safety risk and may need to be replaced.

Figure 11 Small scale erosion control fence has successfully trapped rocks but the posts pose a hazard.

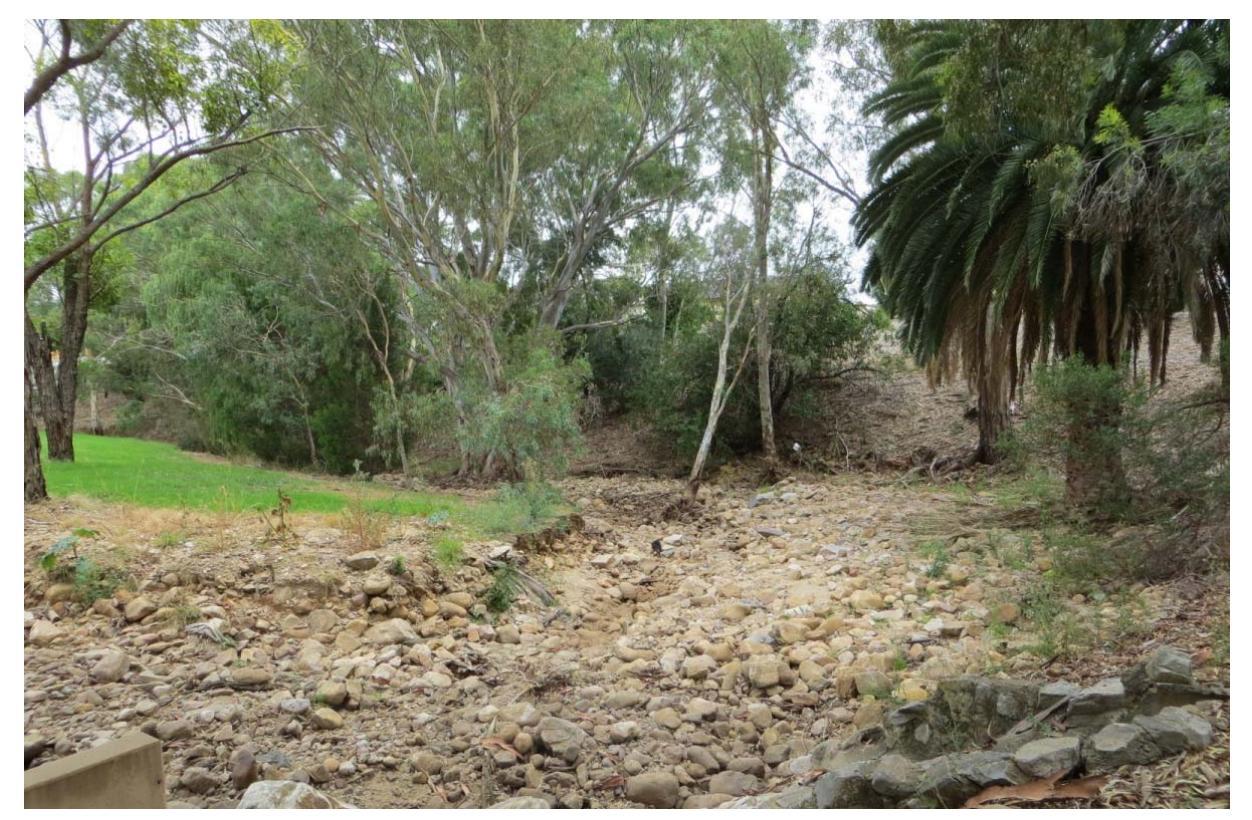
Figure 12 Weedy bend downstream of the trash racks

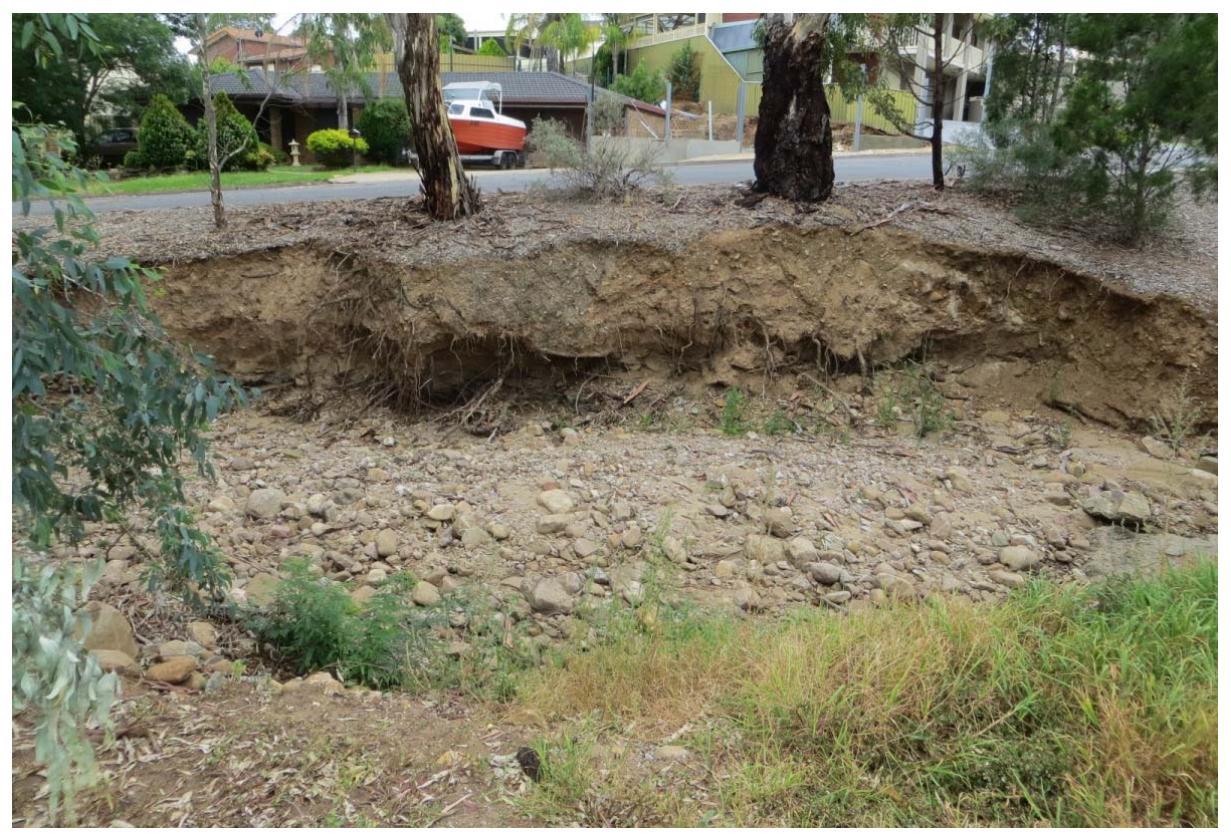
Through the middle part of this section the bed and banks of the creek has eroded (Figure 13). Erosion in this area was noted in the COTMP and so is not entirely the result of the recent floods however the banks appear to be freshly exposed. This area should be assessed by an engineer. Any measures to treat the erosion should combine measures to control bed deepening as a priority and bank erosion where there is a risk to infrastructure. Planting native sedges, rushes and grasses around structures will help to stabilise them.

Watercourse erosion	Bed deepening in the middle section which is contributing to bank erosion
Channel modification	Trash racks installed below the George Street bridge.

Figure 13 Bed deepening and bank erosion adjacent to Heather Court

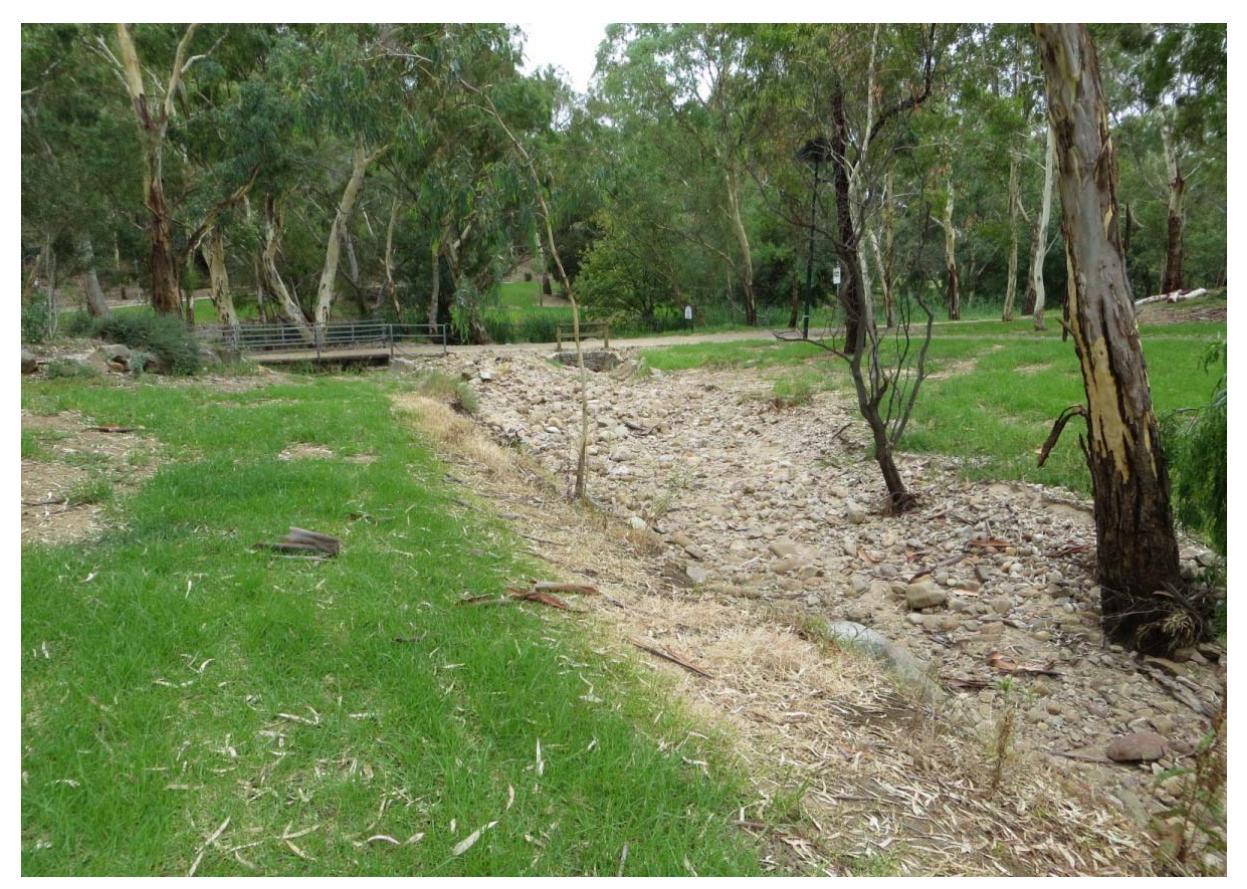
The most downstream end of the creek has an overstorey of River Red Gums over exotic grasses with few high threat weeds (Figure 14). This would be a good site for future understorey revegetation.

Figure 14 Upstream of the outflow of Fifth Creek into the River Torrens
