Third Creek Survey and Management Plan

Report to the Campbelltown City Council

Prepared by Catherine Miles

Miles Environmental Pty Ltd March 2017

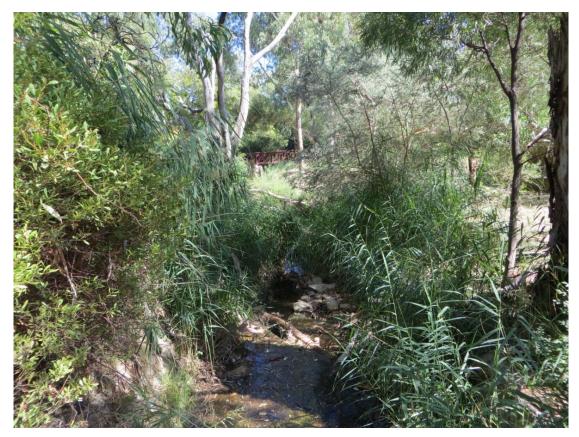
The most upstream part of Section 1 is in the most 'natural condition' (Figure 1) with respect to channel modifications and vegetation composition. Most parts of the creek have been channelised, including through Boord Reserve. Between Norton Summit Road and Vine Street the creek is eroded (Figure 2), presumably from the recent floods. Work has begun in this area to reinforce the banks with rock, however further work is required to address channel deepening.

Figure 1 The upstream end of Section 1 contains some native watercourse vegetation and the channel appears unmodified

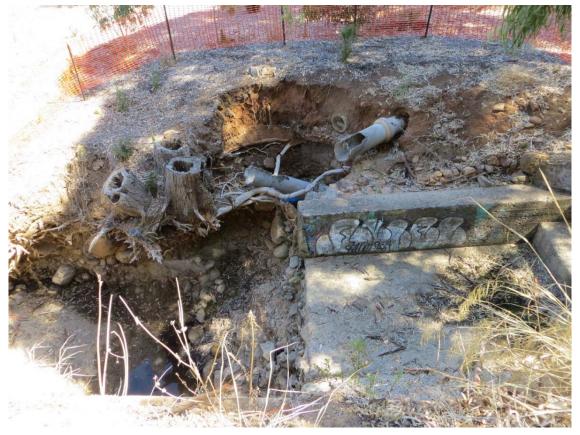
Figure 2 Erosion downstream of the Norton Summit Road bridge

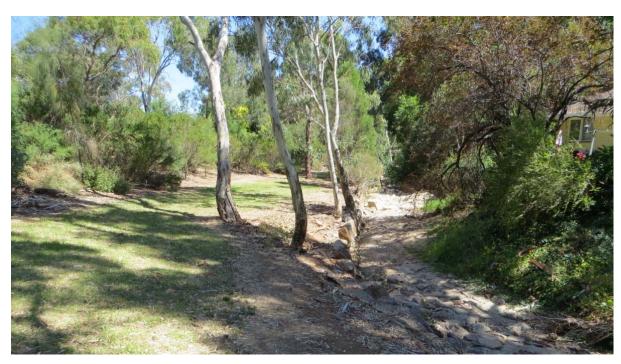
Figure 3 Boord Reserve showing revegetation areas set back from the creek banks on the south side but gardens extending to the north banks

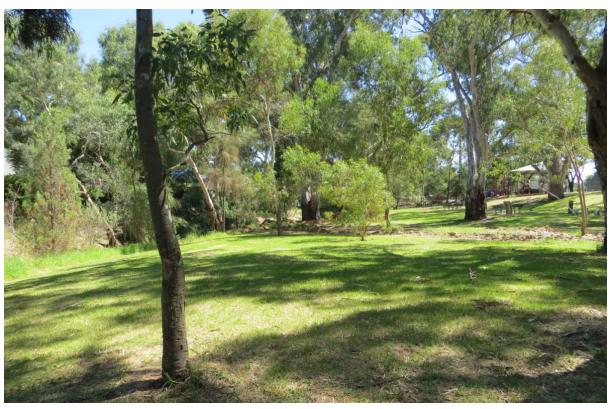
- Nightingale Reserve, where a small number of native species have been planted along the creek banks and the reserve contains River Red Gums over exotic lawns (Figure 4). This area could be enhanced by further scattered plantings of small tree species (e.g. Drooping Sheoaks and Blackwoods) and areas of groundlayer plantings around the base of large trees. The south banks are covered with Periwinkle. The reserve contains a children's playground therefore planting shrubby species that can block lines of sight should be avoided (see section 5.2.2).

Figure 4 Nightingale Reserve

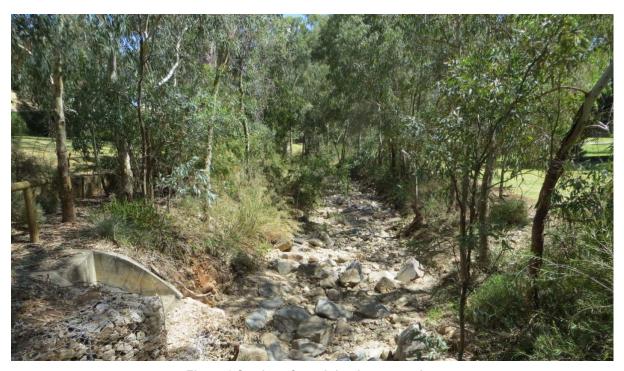
| Feature | Condition |
|---|---|
| Watercourse condition | Good to poor: there is a short section where the natural channel has been revegetated on the banks and there is a high density of native Stiff Flat-sedge (Figure 6), however upstream of this the channel is concrete lined and downstream it is deeply eroded. |

Figure 6 Section of good riparian vegetation

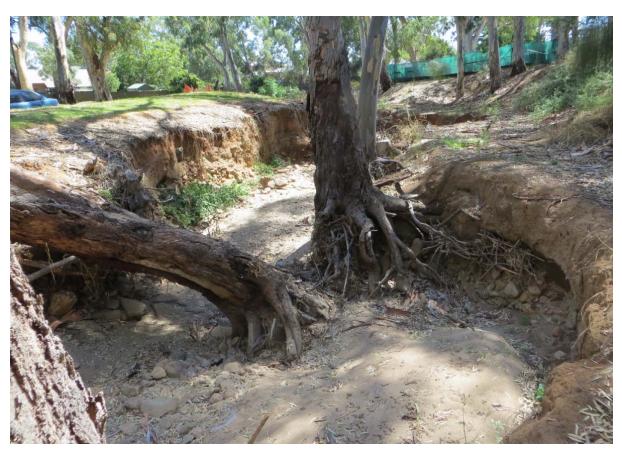
The downstream section of watercourse (below the second footbridge) is eroded, with banks between 1.5 and 2 metres high (Figure 7). Minimal bed deepening probably occurred in the recent floods, but the banks appear to have widened and several trees have had their roots exposed. The COTMP (Swanbury Penglase 2014)) notes that although the creek was deep the banks appeared to be stable. An assessment should be undertaken here to determine if there are any risks to safety or infrastructure that need to be addressed. Any works undertaken in this section should incorporate establishing riparian vegetation, particularly at the toe of eroding banks. The banks are currently sprayed in this area, leaving them bare and contributing to the erosion potential.

| Feature | Condition |
|---|---|
| Watercourse erosion | Bed deepening and widening downstream of the second footbridge, with instream trees undermined. |
| Channel modification | The top section has been concreted. There is a weir between the first and second footbridge. Some of the lower eroded part appears to have had rock and bank reinforcement in the past that has failed. |

Figure 7 Eroded lower half of the creek with trees undermined. Note the sprayed out, bare upper banks.

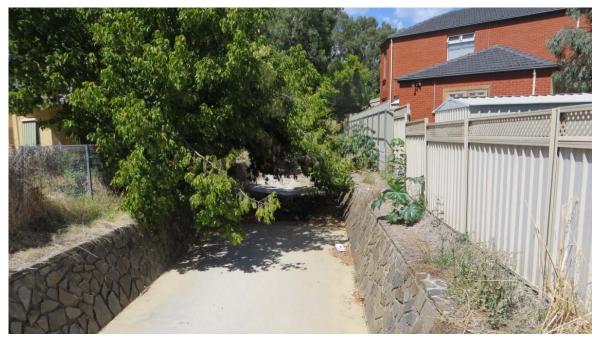
| Feature | Condition |
|---|---|
| Watercourse erosion | None, however a large section of the base of the concrete channel is absent (washed away?) just upstream of Windsor Avenue which may be a concern and should be assessed by an engineer. |

Figure 8 Section Three is predominantly a concrete lined channel. Below the tree the concrete is absent, although this is not easily visible in the photo.

Over time, the concrete lined-channels of Third Creek may become damaged and require repair or replacement (e.g. see Figure 8). Consideration should be given to the use of sloped rock gabions, such as have been used upstream of Lorne Road (Figure 9), as an alternative to concrete, subject to an engineering assessment. The gabions would allow infiltration of stream flows to recharge local soil water and groundwater stores. Smaller native species could be planted along the top of the gabions to spread across the gabions, e.g.

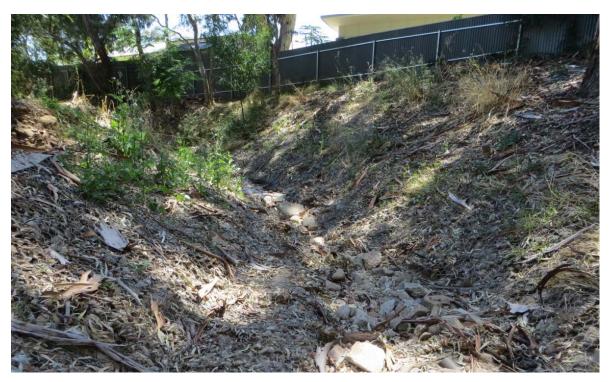
Figure 9 Sloped rock gabions between Magill Campus and Lorne Road

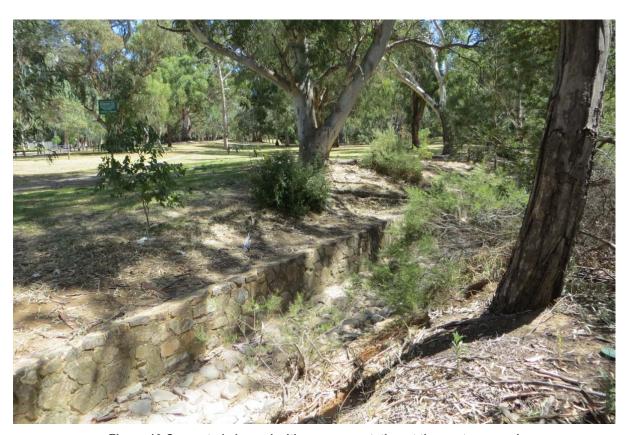
Figure 10 Concreted channel with new revegetation at the upstream end

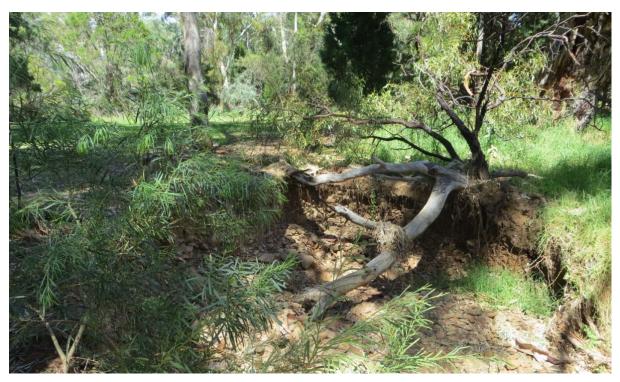
An erosion head on an outer bend (see Map 5, Figure 11) may have been caused by overland flow in the recent floods, in which case it has the potential to continue into the grassed area of the reserve in the event of further floods. This site should be assessed by an engineer to determine the risk and if remediation is required.

Figure 11 Erosion head with potential to extend during flooding

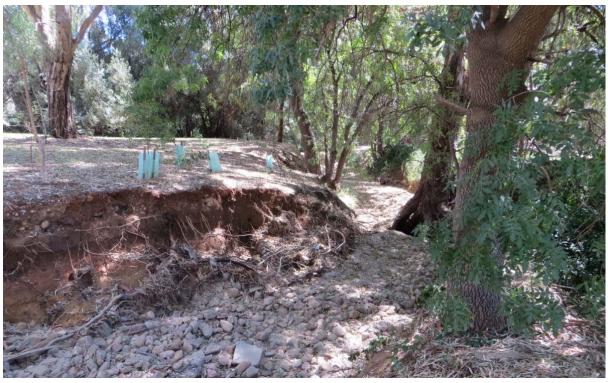
The vegetation of the downstream end is large Olives, mature and seedling Desert Ash trees and large patches of Periwinkle (Figure 12). The soil is bare where the Periwinkle is not growing and there is some erosion of the banks. Some local native seedlings have been planted. Removal of the exotic trees in this area is a low priority in the context of other work required in The Gums Reserve, however, in the longer term their removal will reduce the weed seed load in the area as well as enabling expansion of the area of native vegetation in an urban area where there are few other areas to do so. The removal of the trees will need to be done in conjunction with Periwinkle control and re-establishment of native vegetation and potentially artificial soil cover such as jute matting to prevent erosion.

Figure 12 Downstream end with Olives and Ash trees over Periwinkle. Note the planted seedlings.

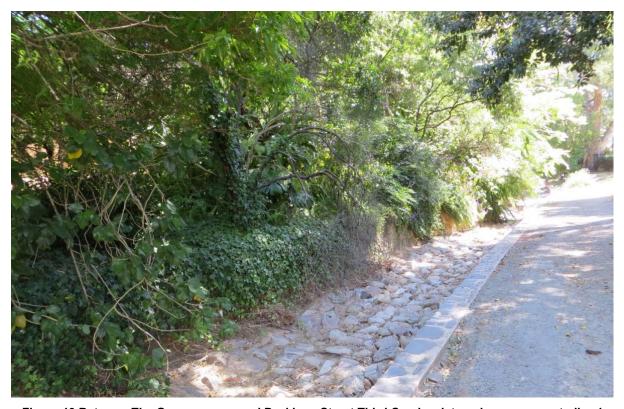
Figure 13 Between The Gums reserve and Peckham Street Third Creek exists only as a concrete-lined channel with gardens on the south (left) bank and a footpath on the north (right) bank

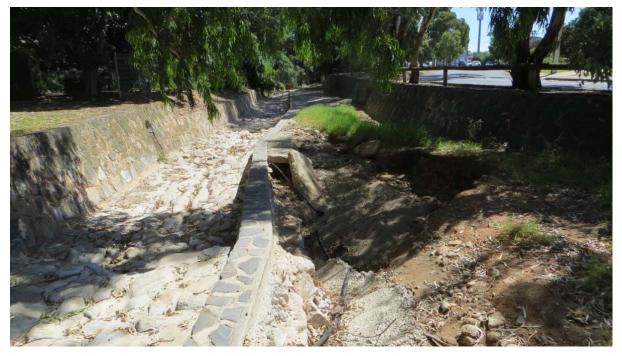
| Feature | Condition |
|---|---|
| Watercourse erosion | On north side of channel in reserve. |

Figure 15 Erosion on the outside of the channel adjacent to Richardson Avenue
