Fourth Creek Survey and Management Plan

Report to the Campbelltown City Council

Prepared by Catherine Miles

November 2016

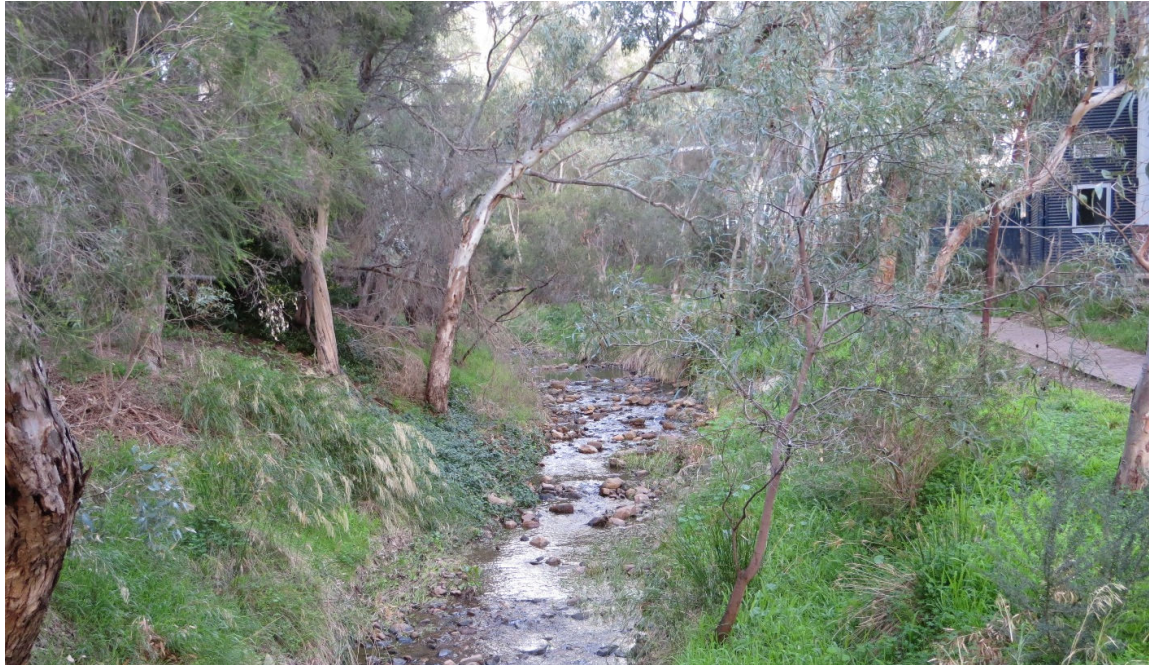
Figure 1 Revegetation area adjacent to Stradbroke Primary School and Scout Hall at lower end of subsection 1, May 2016

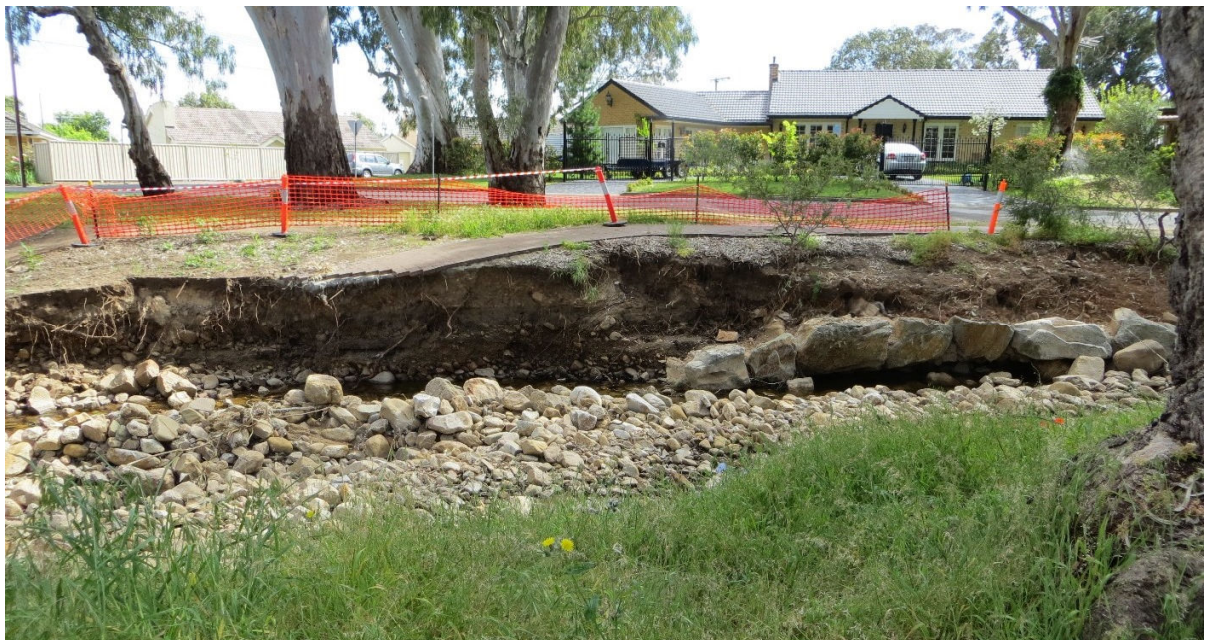
Since 2016 floods there has been erosion damage to some sections, with one section of footpath washed away (Figure 2) and erosion very close to the adjacent roads. Older concrete bank protection structures have been undermined and broken up but gabions do not appear to be damaged. A dead tree has fallen near the upper end but is supported by another tree and a large tree has been undermined and slumped into the creek below the footbridge at the corner of Fairleys Road and Leabrook Drive. Both trees may need to be removed for safety reasons but the logs could be used in the adjacent reserves for habitat or play structures.

Figure 2 Erosion of the banks leading to loss of the footpath. Note large rocks that have been placed here prior to the 2016 floods indicate the previous channel alignment.

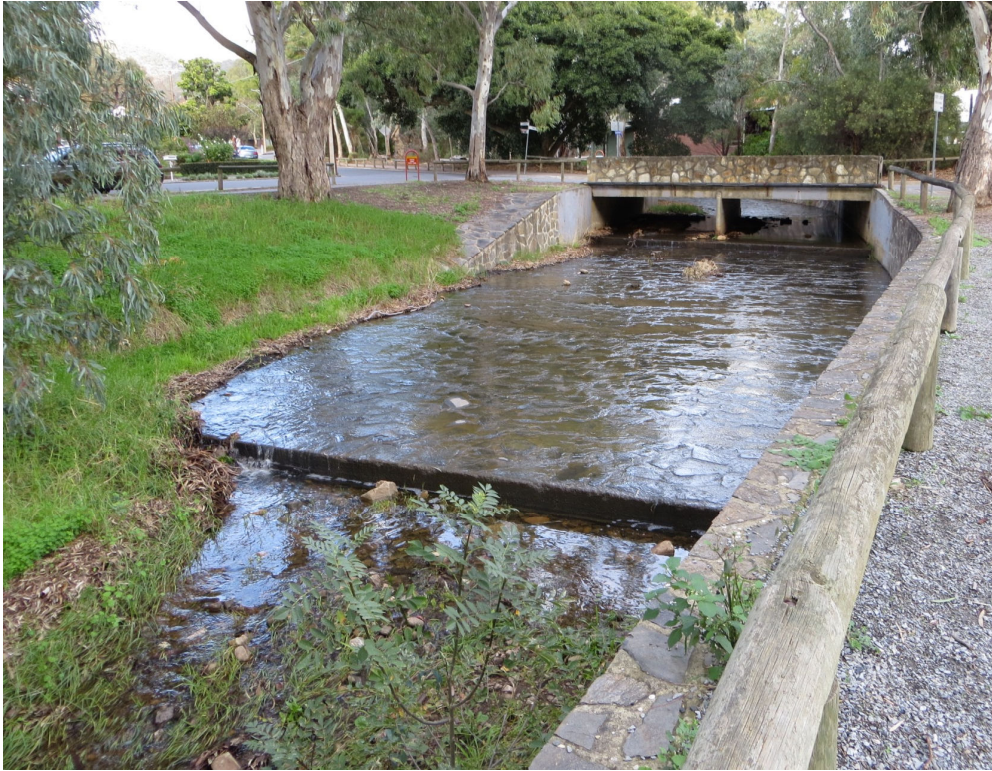
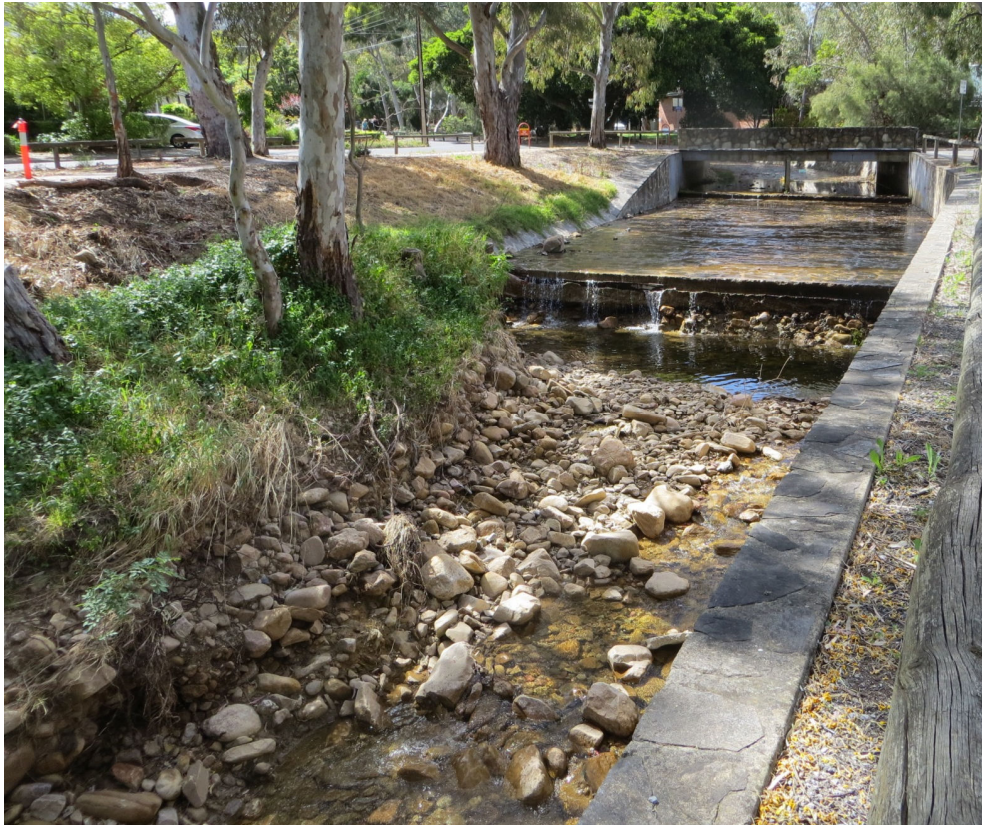
Figure 3 Upstream end of subsection 2 in May (top) and November (bottom).

The channel bed has dropped by almost approximately a metre with a deeper scour pool below the bridge concrete. Note the Ash saplings in observed in May photo that are no longer present following the floods. Note also the close proximity between the channel and the roads on either side.

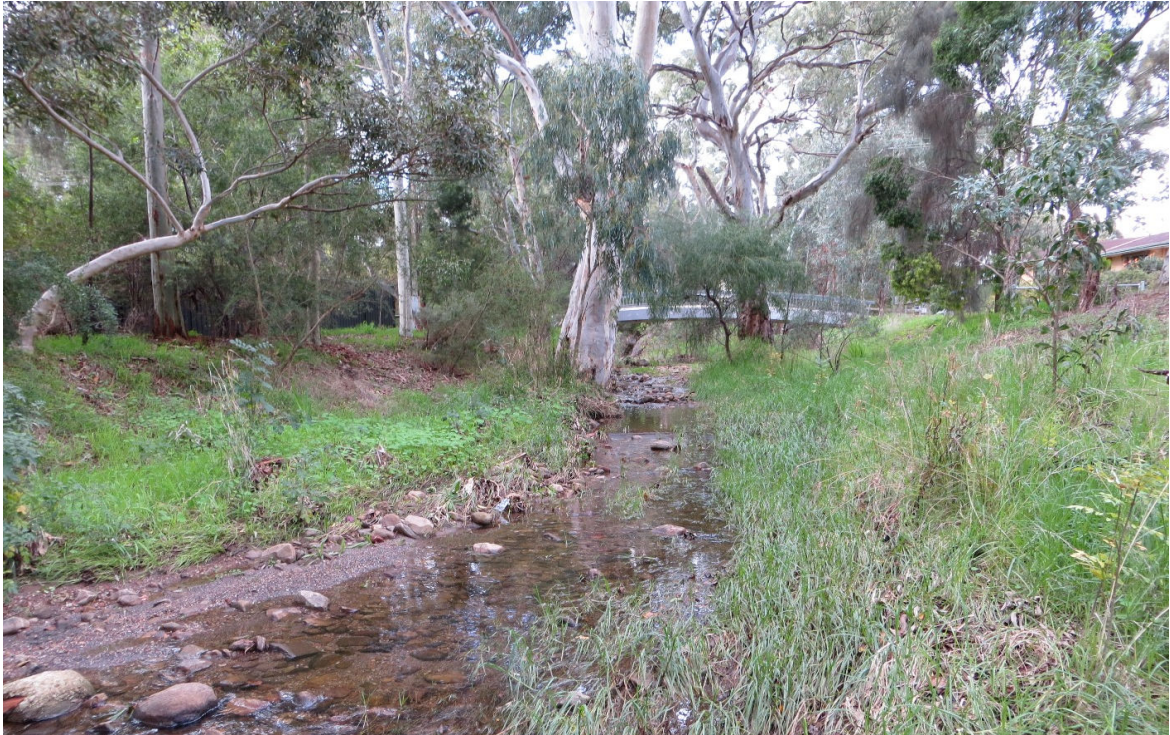
Figure 4 Older local and non-local native revegetation in subsection 3, Ash seedlings and Kikuyu along watercourse edges, May 2016

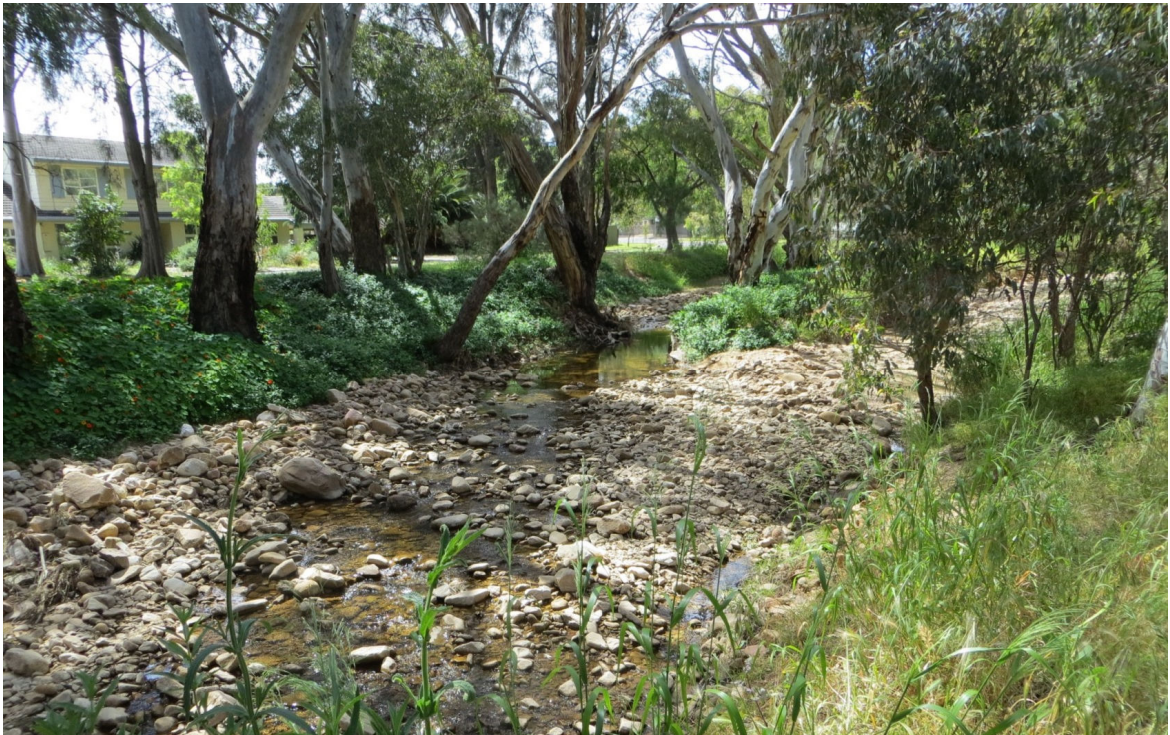
Erosion damage from the floods has been minor and the wider riparian reserve width reduces the risk to infrastructure from erosion (Figure 5). The most severe erosion is at the downstream end where the creek is narrowest and there has been some channel bed deepening and widening. Existing gabions have remained stable but some rock protection works require repair works.

Figure 5 Showing the channel bed scoured clear of sediment and vegetation in November 2016 but without bed deepening

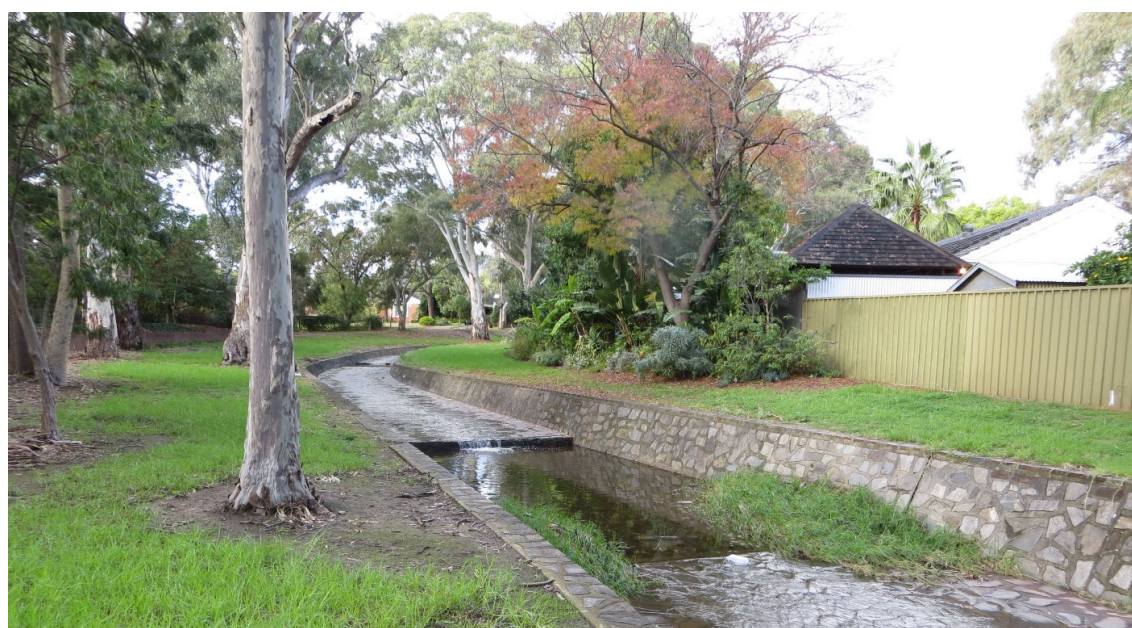
The channel has been concreted for the entire length (Figure 6) which limits the potential to restore any habitat. The upper end of the channel has eroded on both sides in the floods of 2016 and the concrete been undermined and pipework exposed (Figure 7). The erosion indicates the channel capacity is insufficient for the flows experienced in 2016 and, while infilling the eroded sections may provide a short term repair, it is likely that a similar level of erosion would occur again under high flows. Consideration should be given to removing the concrete lining and restoring a 'natural' channel bed which could incorporate rock cleared out from other sections of the creek. Engineering advice would be required if the concrete were to be removed.

Figure 6 Concreted channel with garden plantings by adjacent landholders, May 2016

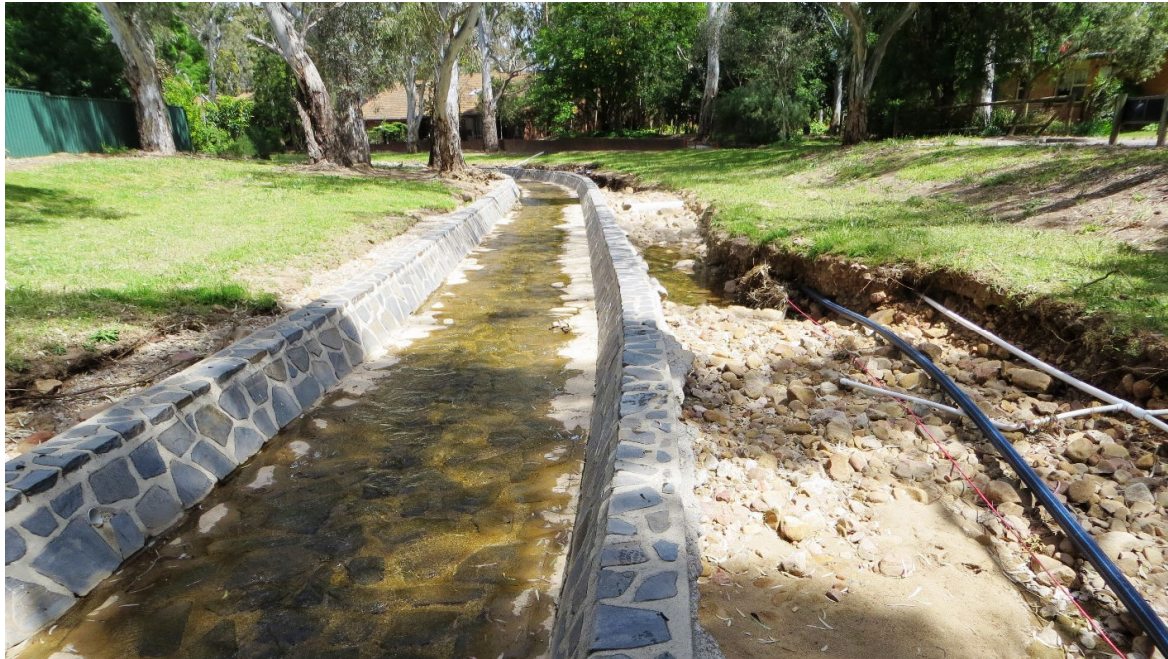
Figure 7 Erosion either side of the concreted channel has undermined the concrete and exposed pipework, November 2016

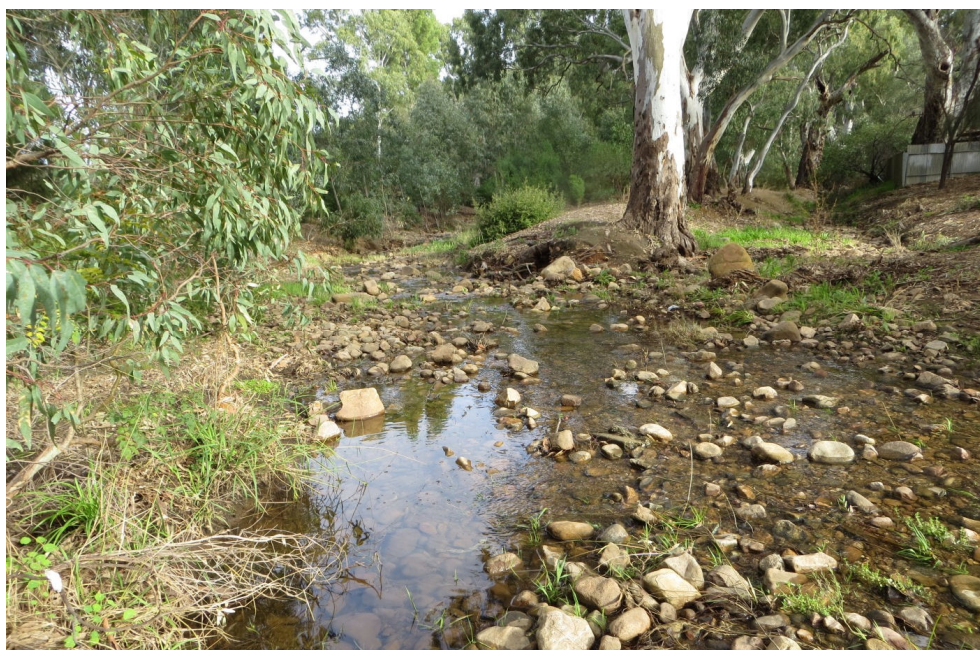
Figure 8 Old River Red Gums and diverse local native plantings in subsection 5, May 2016

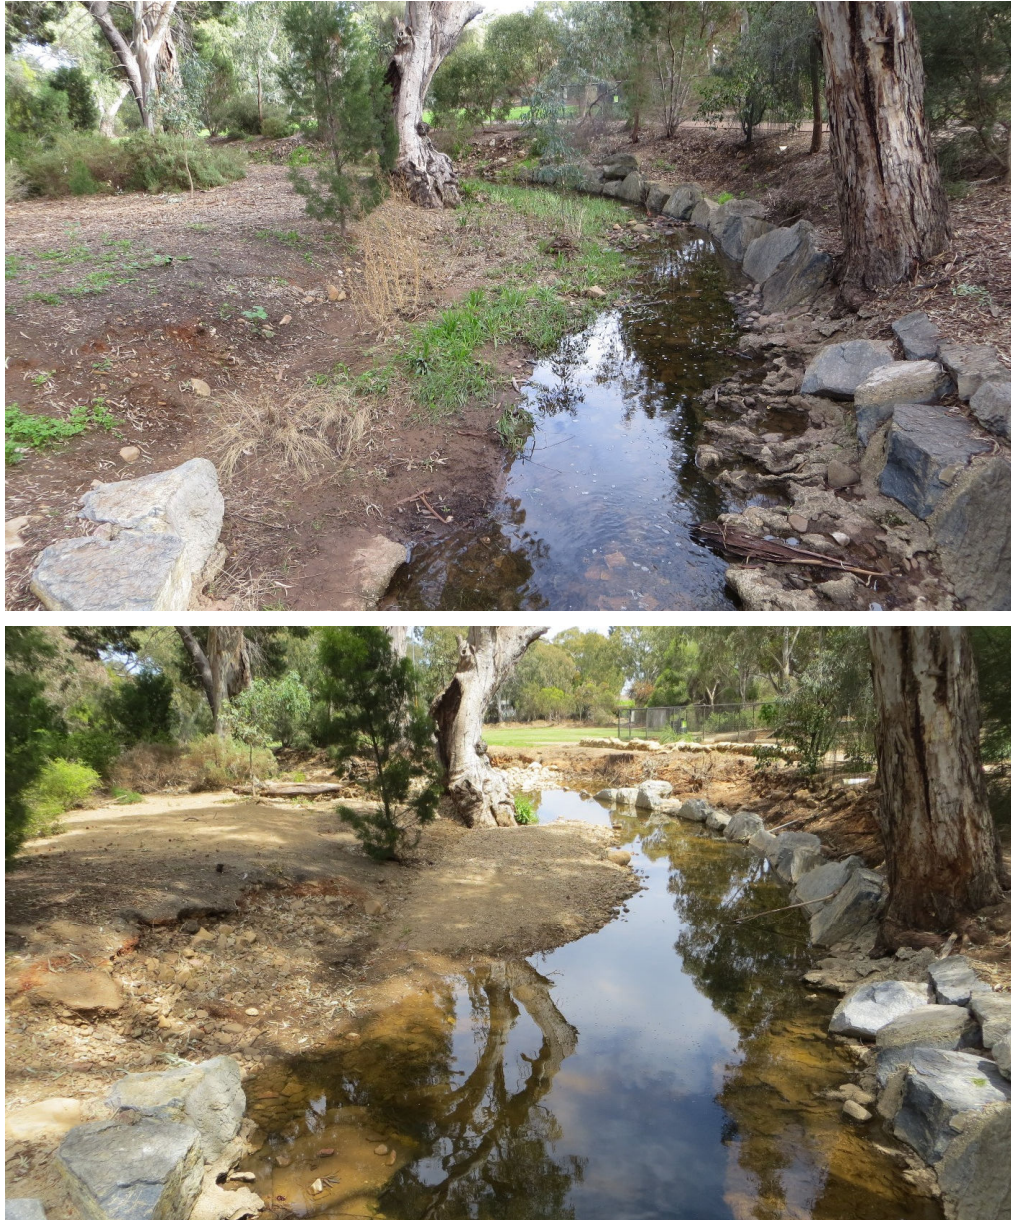
There was major erosion from the 2016 floods which has resulted in damage to footpaths and loss of some revegetated trees and shrubs (Figure 9). Consideration should be given to following the new channel bank alignment when undertaking repair works and incorporating revegetation, with a focus on establishing small dense species to protect the toe of the bank. Scouring below the upstream footbridge has created an undercut pool of over 1 m depth which may be a safety concern.

Figure 9 Upstream end of subsection 5 in May 2016 (top) and November 2016 (bottom)

The channel bed has deepened, scouring below the concrete on the lower right foreground to create a pool over 1 m deep. The north (right) bank has eroded past the rock alignment, removing the revegetation on the northern bank seen in the top photo. Sand has been deposited on the floodplain on the south (left) side.

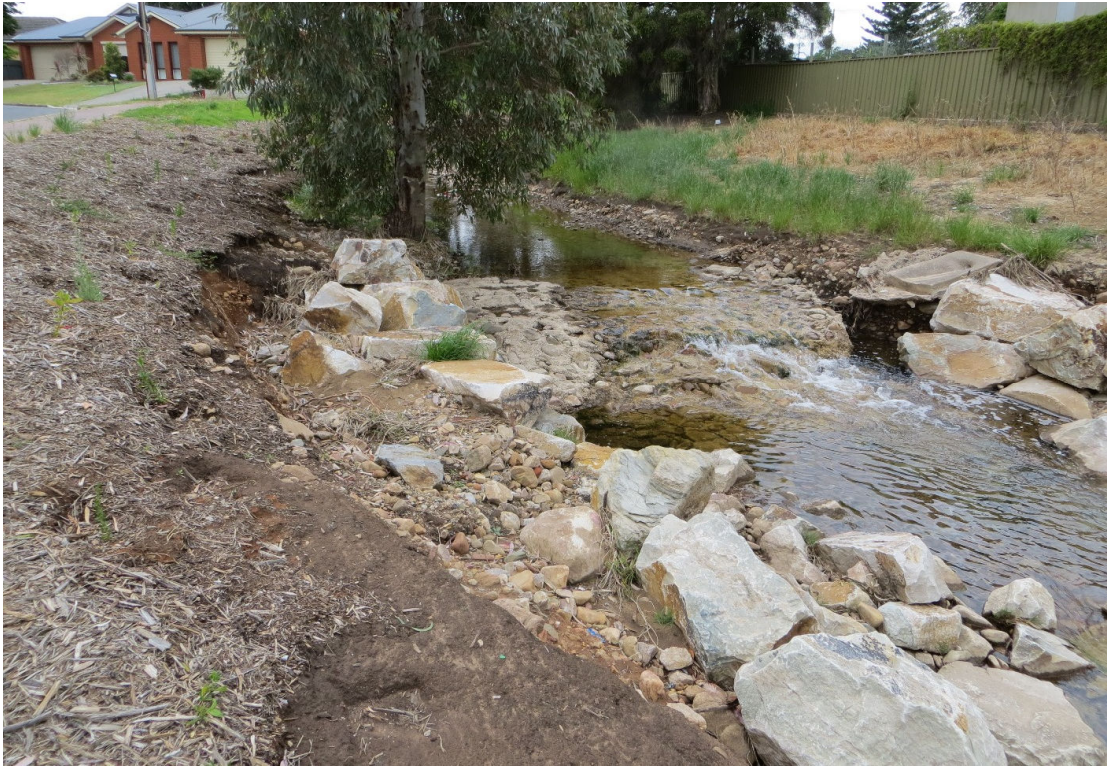
Figure 10 National Tree Day 2016 planting site to the left; the instream concrete weir has prevented bed deepening but minor scouring around the structure has occurred

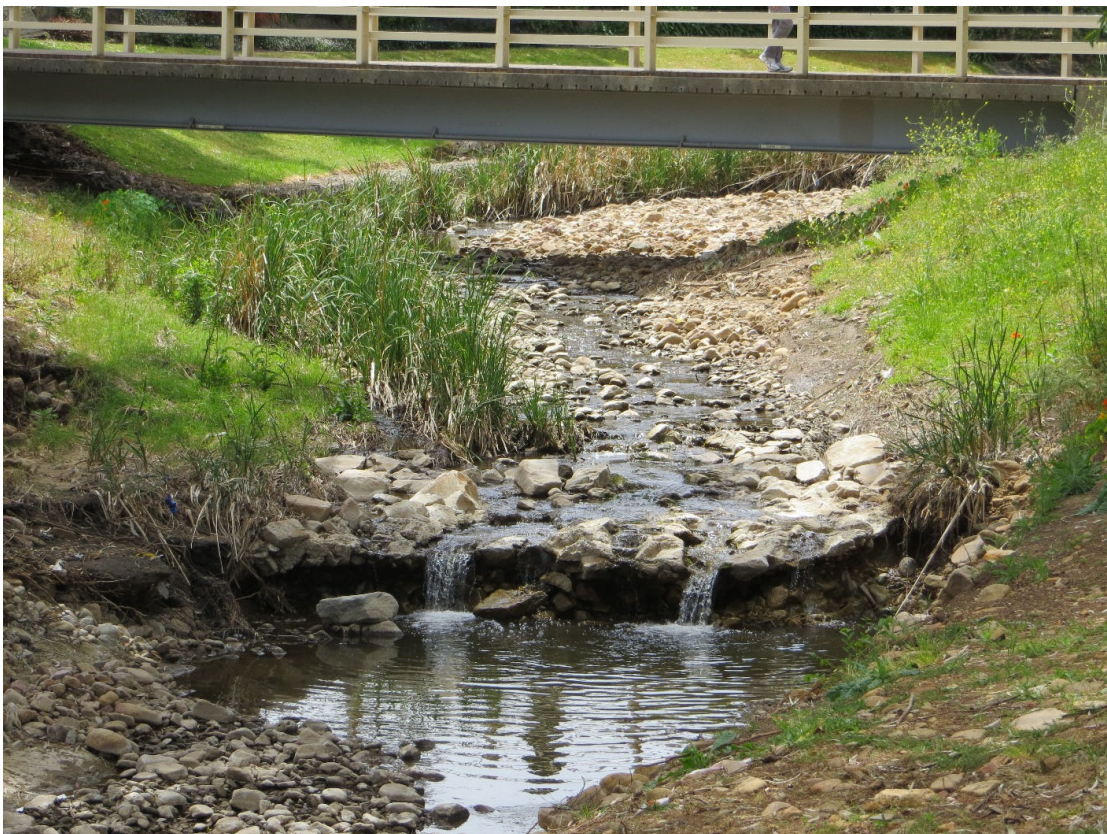
Figure 11 Upstream end of subsection 6 following the 2016 floods; the top layer of sediment and rock has been removed upstream of a concrete weir, along with Bulrushes and Blackberries, but the weir has prevented bed deepening below this level.

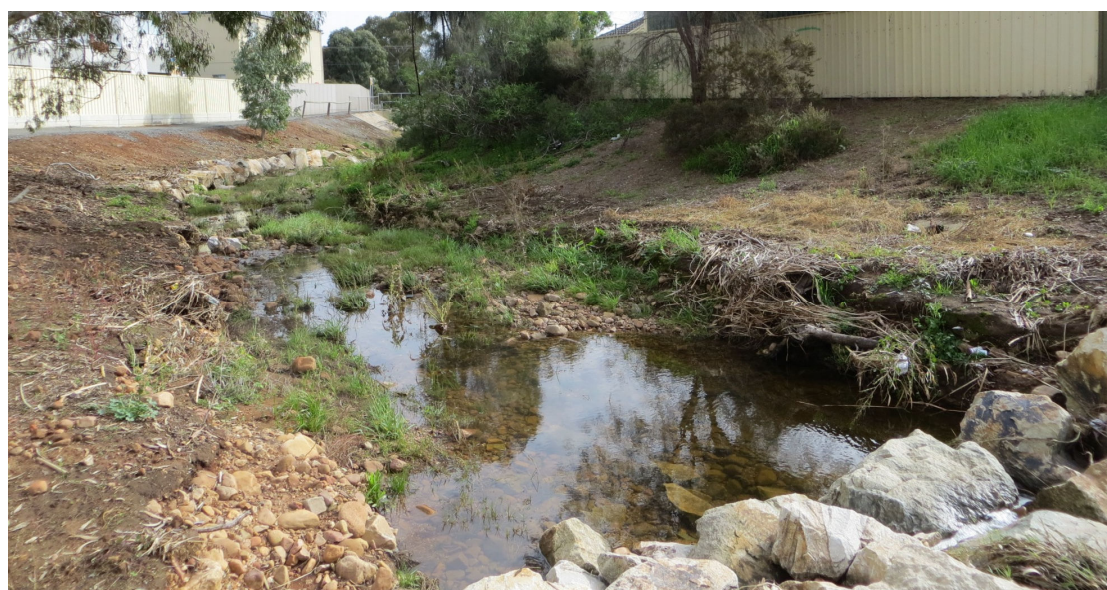
Figure 12 Downstream end of subsection 7 in May 2016, revegetation area on right bank in background without spraying, rocks placed in creek to raise bed level in foreground and on left bank downstream to prevent channel widening

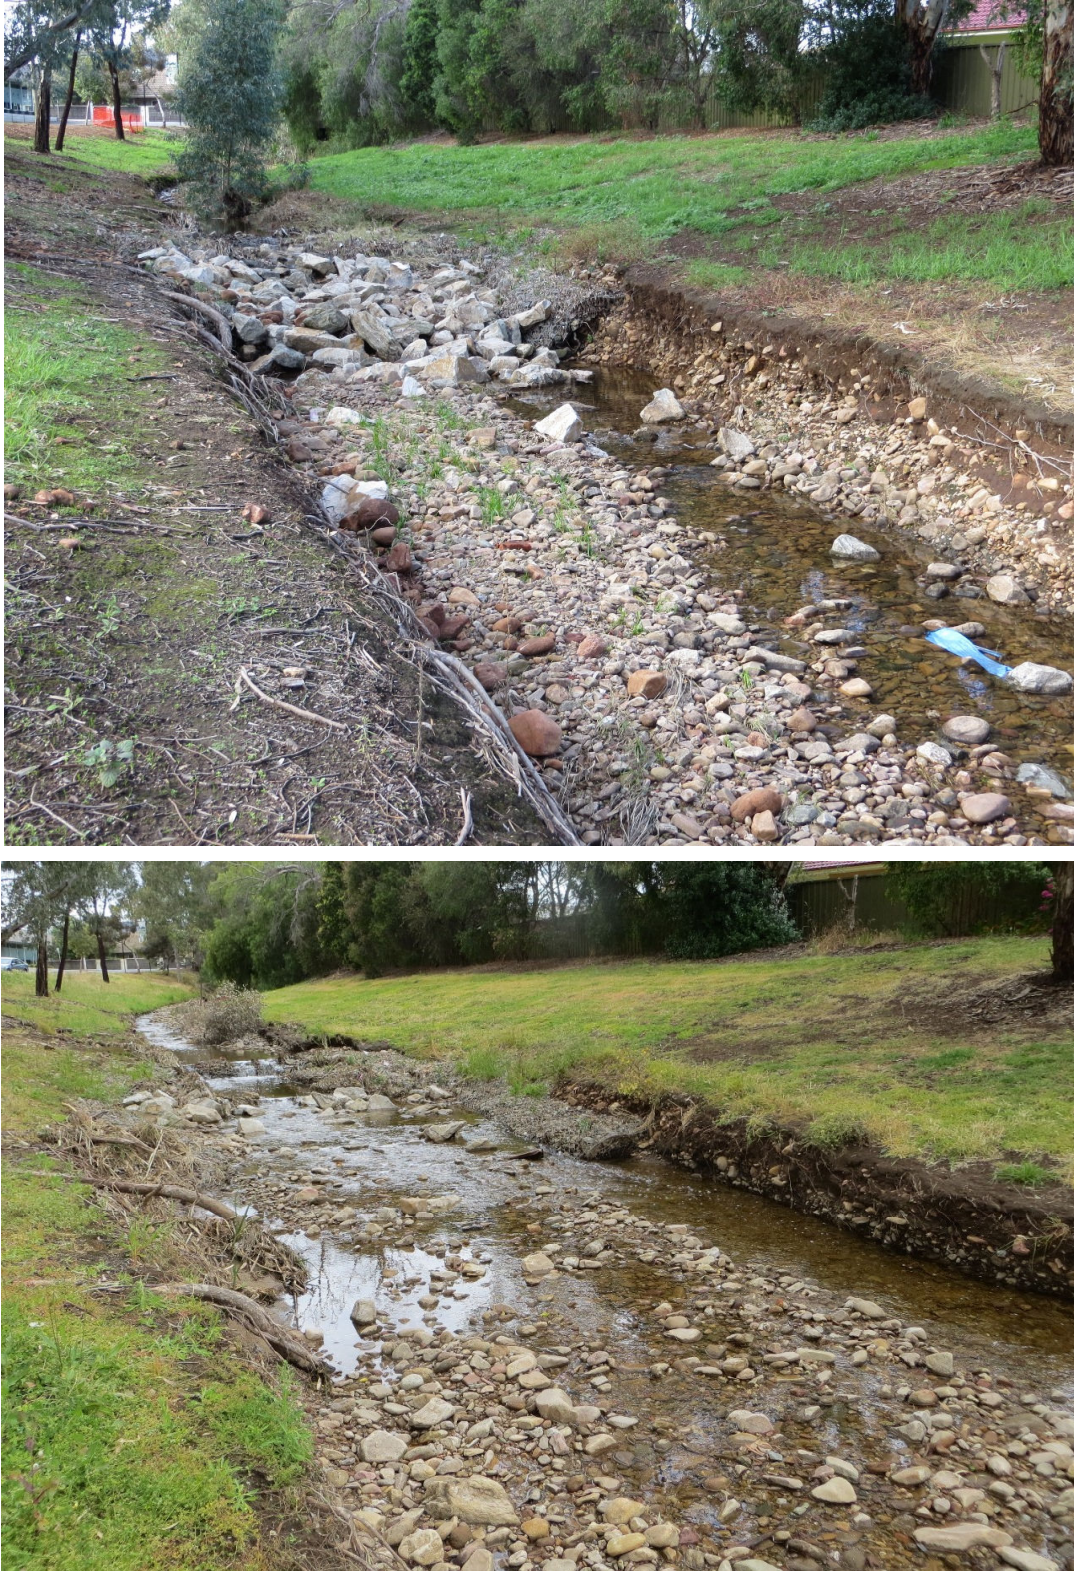
Figure 13 Example of instream rock structure in subsection 8 that was beginning to fail at the downstream end in May 2016 (top), however this was covered in rocks during the floods, reducing the erosion at this site (bottom).

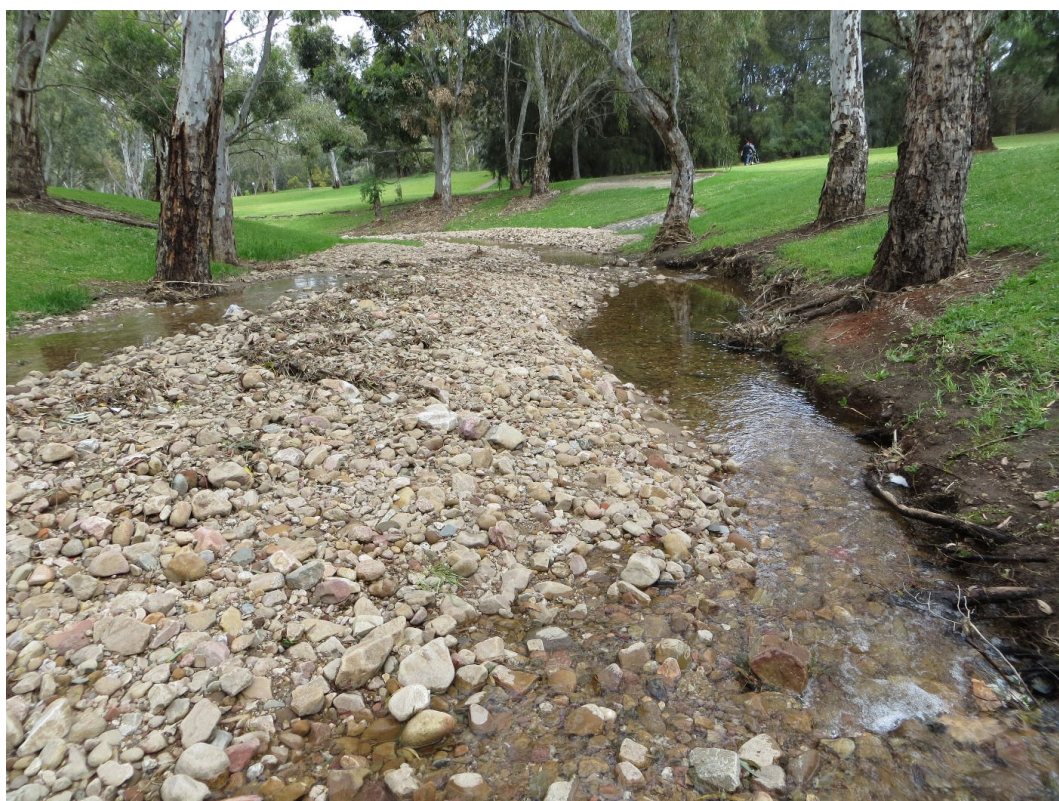
Figure 14 Subsection 9 through the golf course in November 2016 showing rock deposits

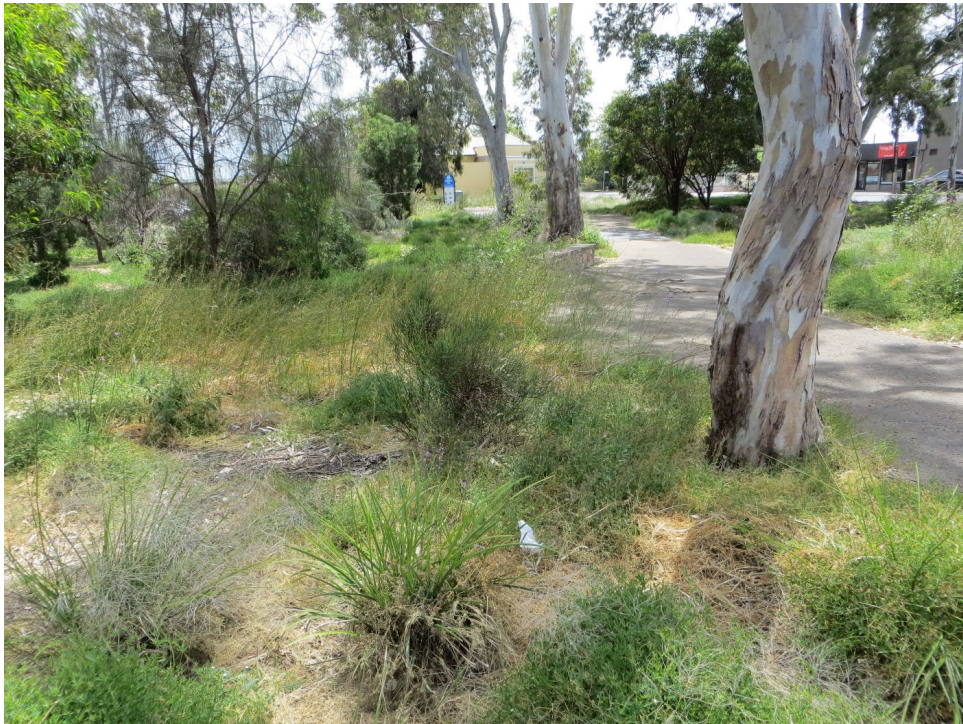
Figure 15 Example of good understorey revegetation in City of Campbelltown Reserve, corner of Newton and Montacute Roads

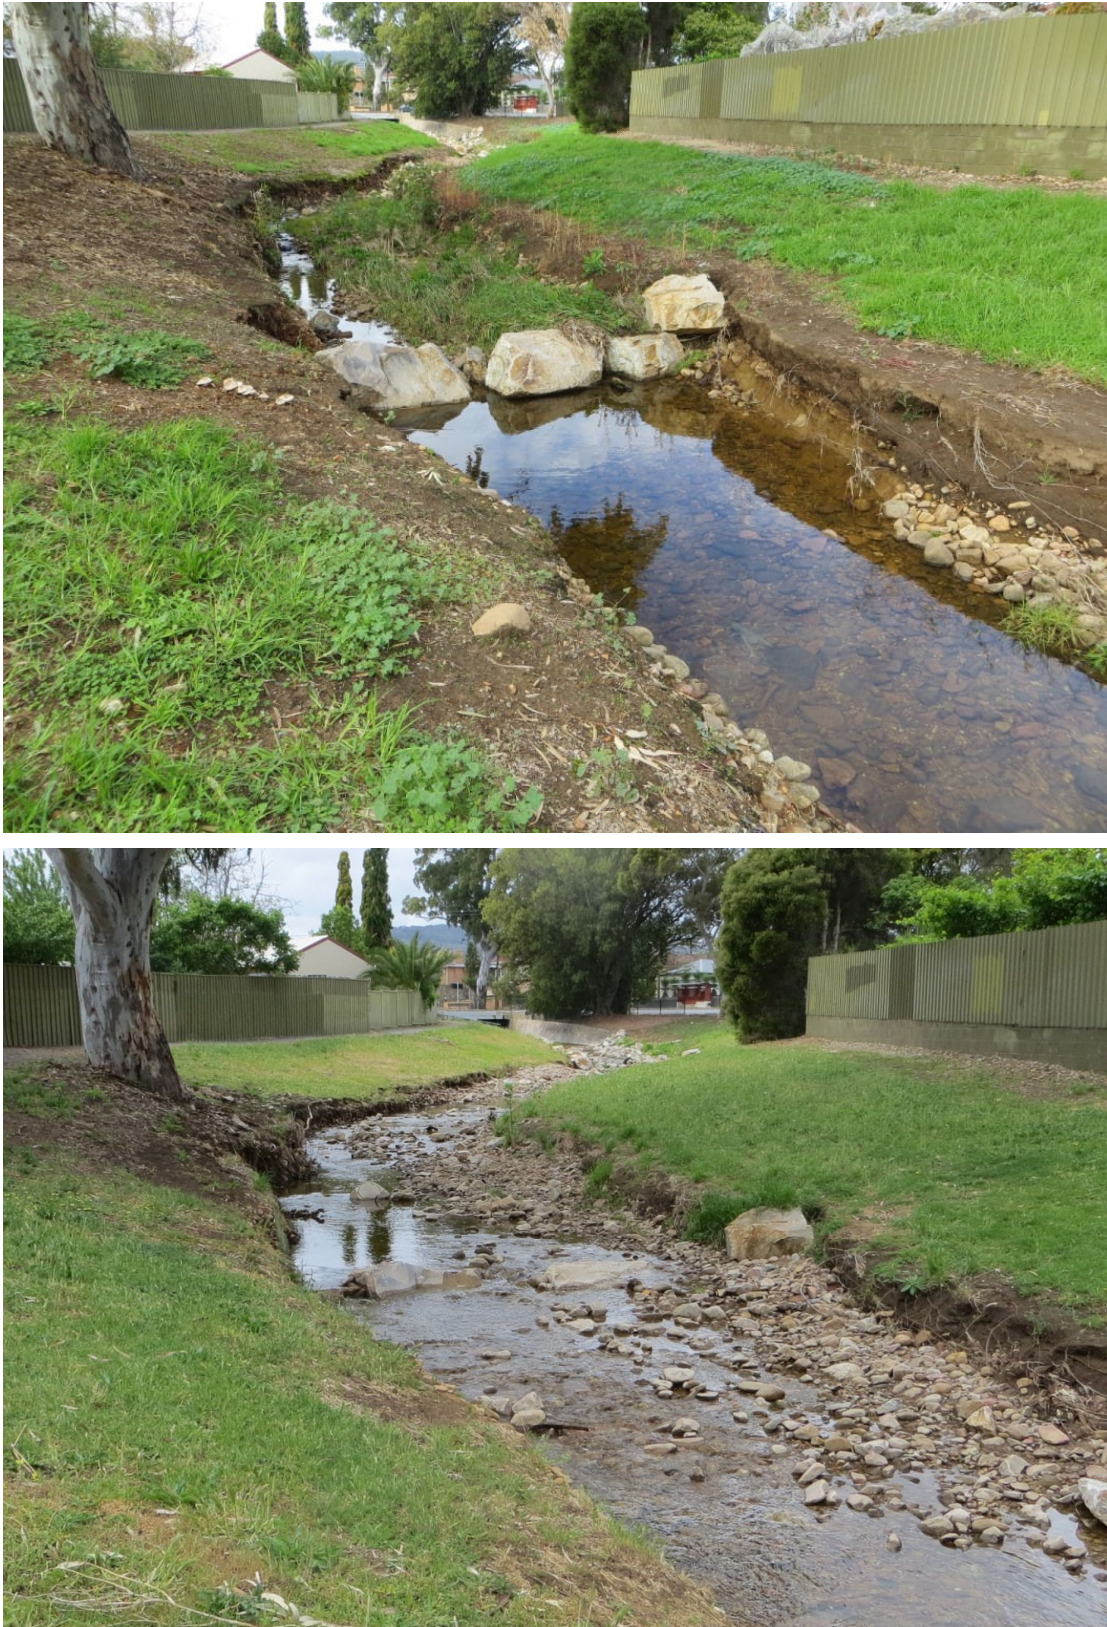
Feature	Condition
Native vegetation condition	Very poor: Sparse large River Red Gums, general absence of understorey, total of 13 native species mainly in one area of revegetation. Narrow riparian widths.
Watercourse condition	Poor: lack of native vegetation cover, although this section had the highest native watercourse species diversity (6 species)
High threat weeds	Woody weeds: Blackberries, Palms, Caster Oil Plant, Swamp Oak, Olive and Flinders Ranges Wattle. A Cactus is spreading from and adjacent garden and a mature Poplar is spreading. Non-woody weeds: Dense Flat-sedge in higher density than the Upper Section prior to floods; Umbrella Sedge and Fennel appear to have been washed away in the floods.
Habitat (terrestrial)	Sparse overstorey
Habitat (watercourse)	Deeper pool near pedestrian bridge, stands of bulrush
Watercourse erosion	Bed deepening at the upper end but deposition during the floods through most of this section has reduced the level of erosion (e.g. Figure 16).

Figure 16 Showing an area in lower subsection 7 impacted by bed deepening and erosion around the rock weir in May 2016 (top) where bed materials from upstream were deposited during the floods (bottom)

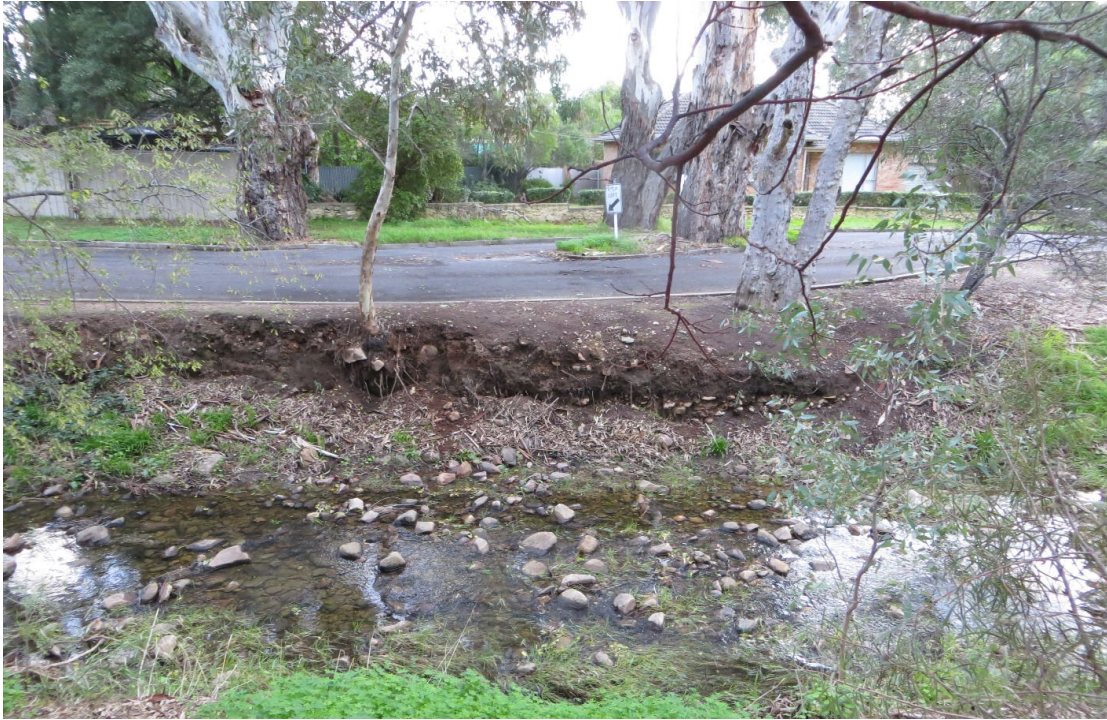
Figure 17 Bank erosion in subsection 2; because of the narrow width, controlling this erosion is important for protecting the road

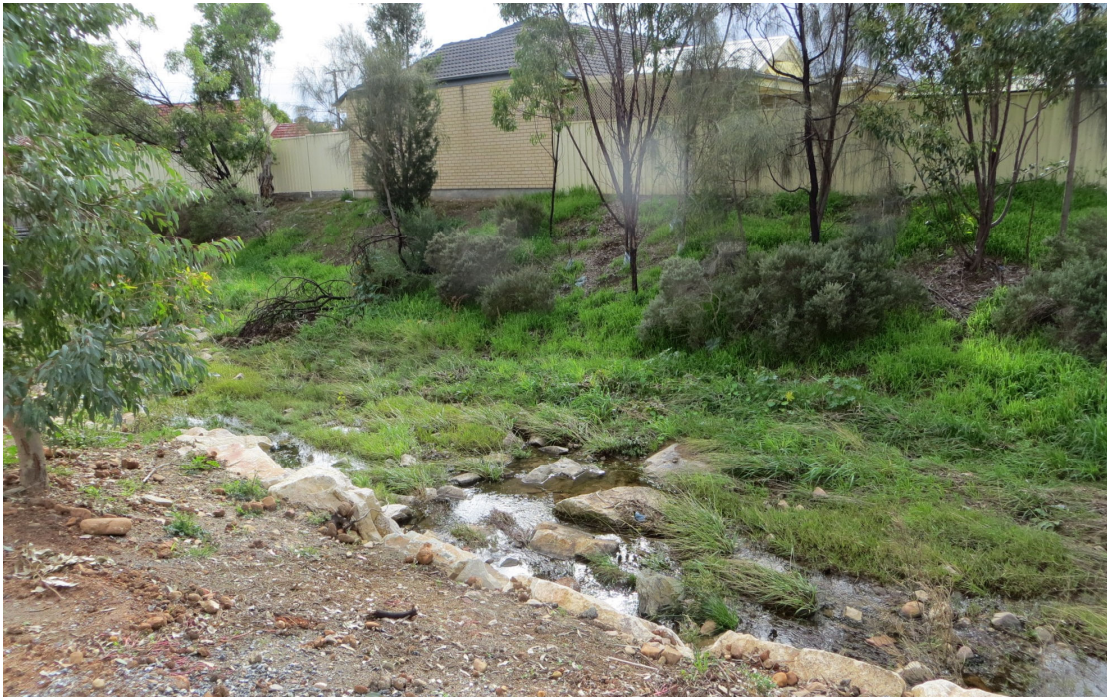
Figure 18 Small area of revegetation in Lower subsection 8 where watercourse edges are not sprayed and grasses provide protection against erosion
