# Fifth Creek Survey and Management Plan

Report to the Campbelltown City Council

**Prepared by Catherine Miles** Miles Environmental Pty Ltd March 2017

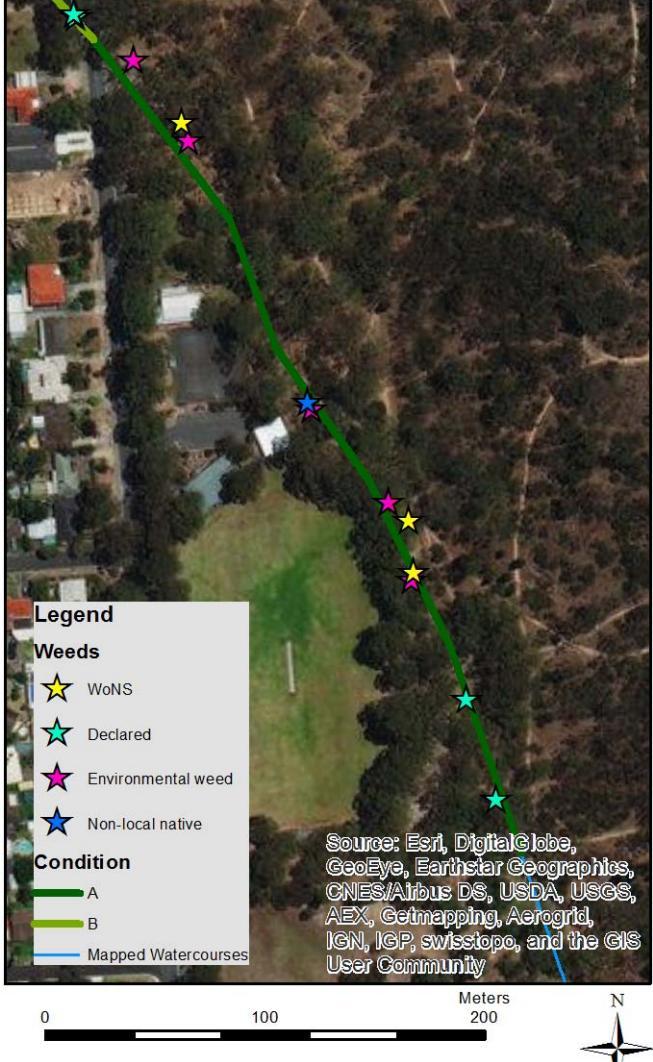
Map 2: Section 1 weeds and watercourse condition

There are a number of weirs constructed in the creek, most of which appear to have been installed for erosion control but also provide pedestrian access across the creek. There is some minor erosion of the banks and some scouring below concrete weirs. The deepest scour pool is behind the sports clubrooms. The structures appear to be stable currently but may become unstable with further erosion and should be monitored. Rock reinforcements near the Maryvale Road bridge appear to be new and further work may be needed in this area to stabilise the soil and rocks - planting native grasses and sedges with organic weed matting may assist.

There were deeper pools of water below concrete weirs and in naturally low lying areas. There was a small amount of instream native vegetation. There is a low abundance of high threat weeds in the site, including on the banks and in the watercourse. However the small number of Weeds of National Significance (WoNS) and declared weeds can spread quickly and are therefore a priority to control. Watercourse weeds include Dense Flatsedge, Hemlock and one occurrence each of Jointed Rush and Giant Reed.

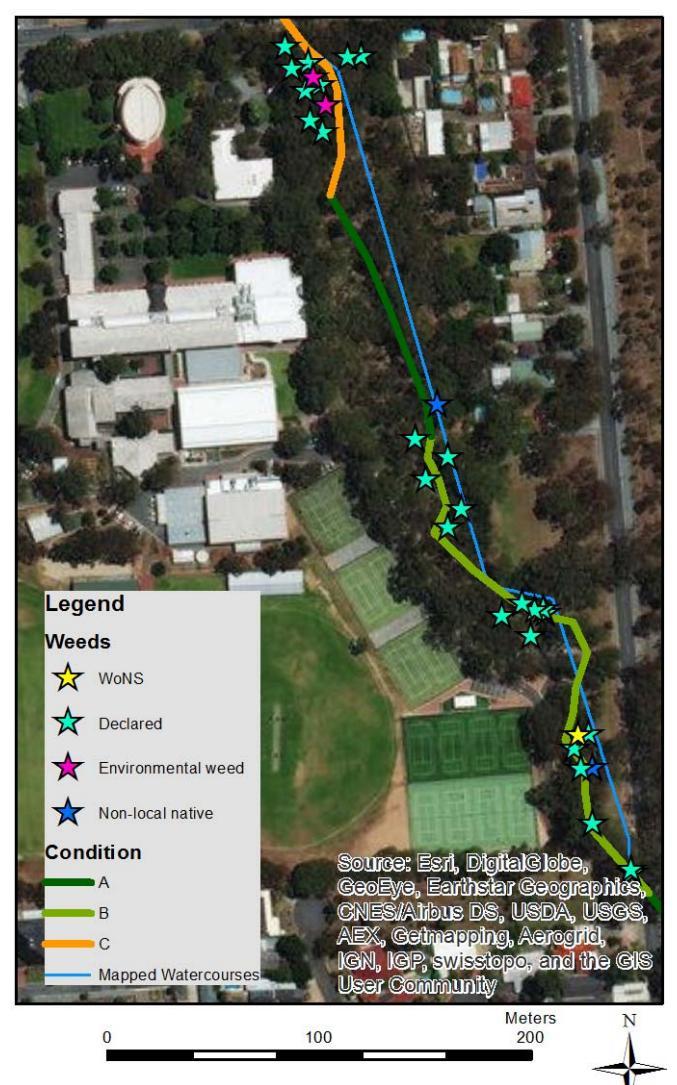
Map 3: Section 2 weeds and watercourse condition

Feature	Condition
Native vegetation condition	Good (25%): Remnant overstorey of River Red Gums with a diverse revegetated understorey and very few weeds.
	Medium (55%): Remnant overstorey of River Red Gums over large and small Olives and Ash trees in the creek and on the right bank
	Poor (19%): Dense weeds amongst remnant River Red Gums
	Total 25 species
Watercourse condition	Moderate: there are River Red Gums seedlings, Stiff Flat Sedge and Slender Knotweed growing in the watercourse, but exotic trees and shrubs line much of the watercourse. The watercourse itself appears largely unmodified and there was limited erosion.
High threat weeds	Exotic trees: Olives and Ash in the upper and lower ends. Non-local natives: Golden Wreath Wattle, Flinders Ranges Wattle and Sweet Pittosporum. Isolated Montpellier Broom, Italian Buckthorn, Palm Tree and Giant Reed. One patch of Gazania and one of Nasturtium. Periwinkle is only found in the downstream end. Exotic perennial grasses throughout but in low abundance. Exotic climbers English Ivy and Morning Glory in the downstream end.

Removal of the Olive and Ash trees and other high threat weeds in the upstream (medium condition) part of the watercourse is recommended as a priority for Section 2 as it will reduce the weed threat to the adjacent revegetation area and enable the revegetation to be extended into this area, linking with the Wadmore Park / Pulyonna Wirra. Weed control in the lower end should focus firstly on ensuring the weeds do not spread into the revegetation area. Removal of the weeds should be undertaken in the longer term, working from upstream to downstream, to reduce the weed threat to downstream areas.

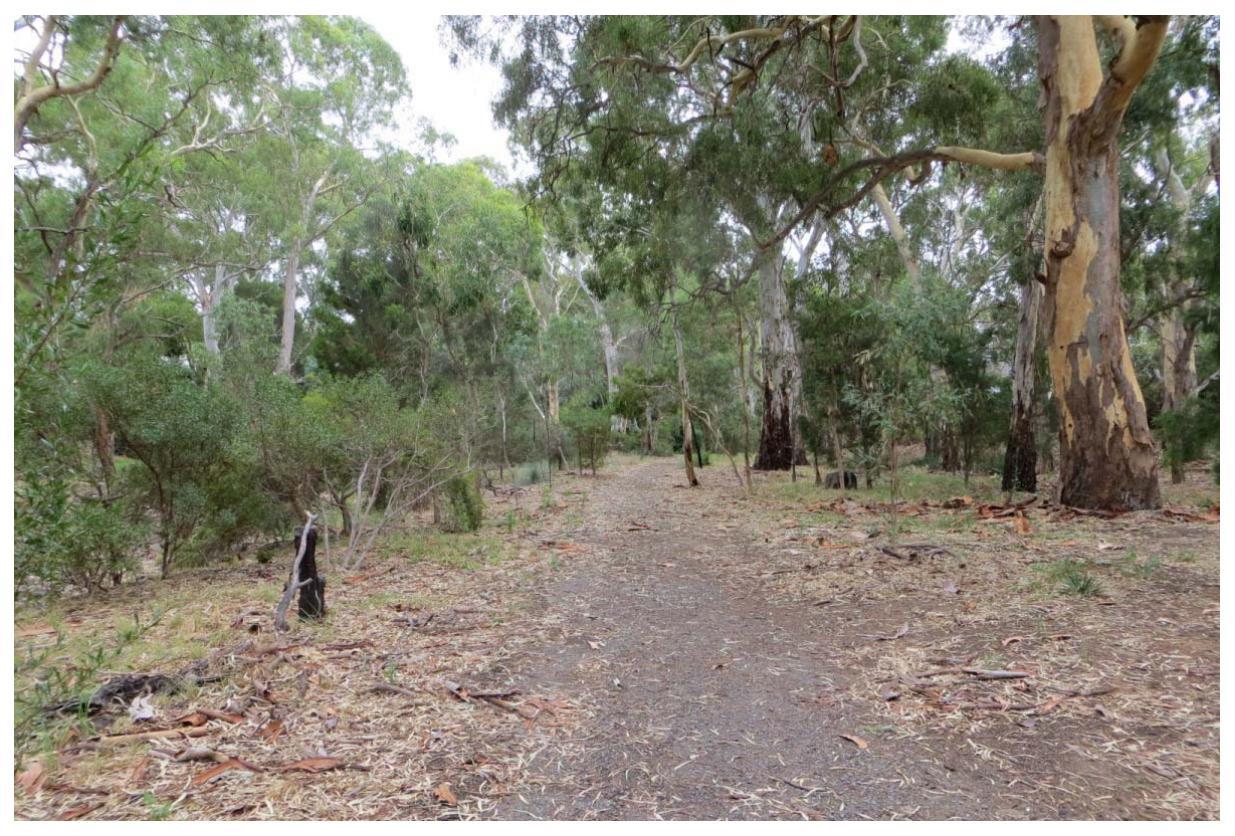
The middle part of Section 2 has been revegetated and comprises a good mix of local native species, including groundlayer species (Figure 4). There is regeneration of some planted species, and some of the species may have colonised the site naturally; these are signs that the site is becoming self-supporting and the management of this area should focus on 'bush care' over revegetation.

Figure 4 Revegetation area

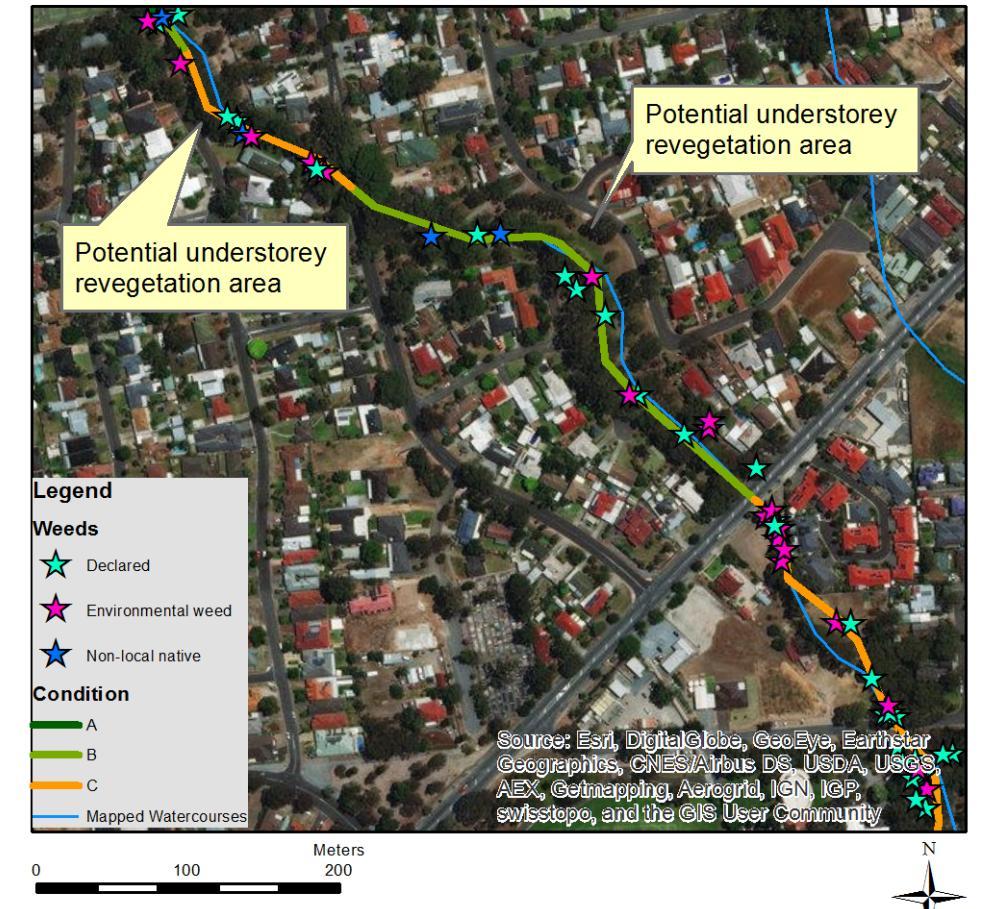
Map 4: Section 3 weeds and watercourse condition

Between Manresa Court and Gorge Road the creek runs through private property and was only surveyed from the adjacent roads. There are exotic trees and shrubs through this section with an overstorey of River Red Gums (Figure 6). The banks have been sprayed out and are bare and there is some bed erosion.

There is some minor erosion, the most severe of which is upstream of Gorge Road and downstream of Schulze Road (Figure 8).

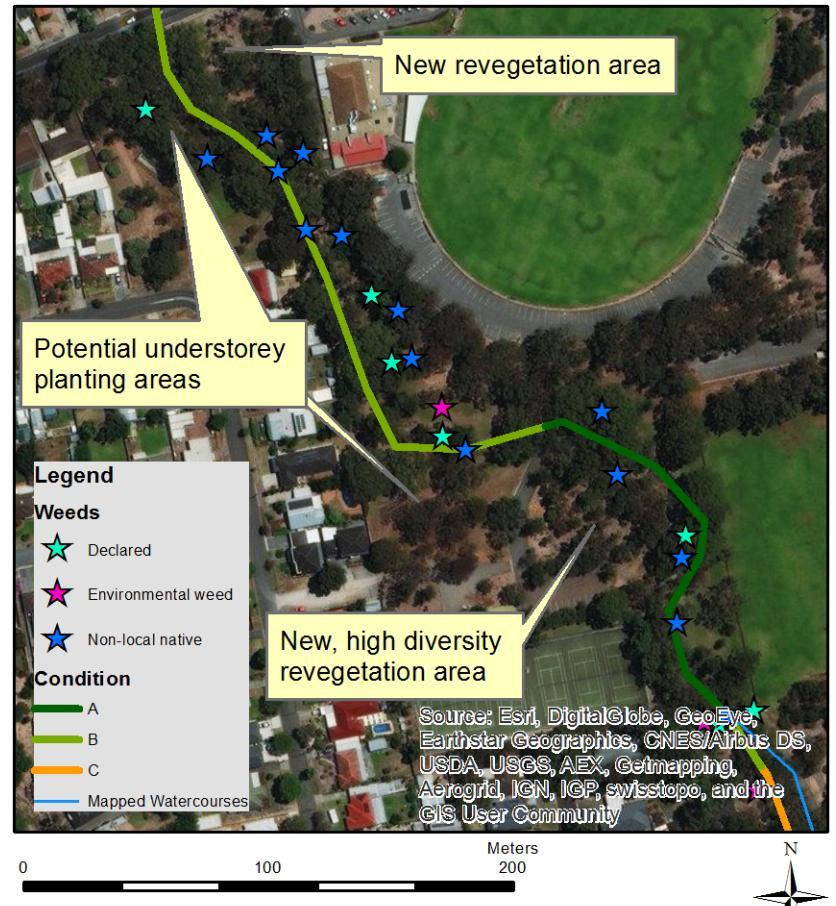
Map 5: Section 4 weeds and watercourse condition

The creek appears to have sustained some erosion damage from the floods last year. This erosion is generally minor except for areas downstream of the floodway, particularly near to the football clubrooms where the banks are close to the building (Figure 10). Engineering advice will be required to determine which areas require works to stabilise them and what should be done,

Feature	Condition
Native vegetation condition	Good condition (39%): Good diversity of local native species planted on the banks and natural River Red Gum canopy.
	Moderate condition (61%): Canopy of River Red Gums but mostly lacking understorey (except some plantings in the north eastern banks)
	Total species diversity: 37
Watercourse condition	Good to moderate: two native sedges as well as one herb and River Red Gums, few in-stream weeds. Some erosion.
High threat weeds	One patch of Lippia, one Olive, Ash re-growth. Isolated Dense Flat-sedge and Giant Reed in-stream. Non-local native species planted throughout with many regenerating.
Habitat (terrestrial)	Overstorey but few hollows, leaf litter, groundcovers and shrubs.
Habitat (watercourse)	Rocky creek bed, occasional sedges
Watercourse erosion	Scouring around and below structures, bank erosion
Channel modification	Erosion control works

however the planting of local native sedges, rushes and grasses around any new (and existing) structures will help to stabilise them.

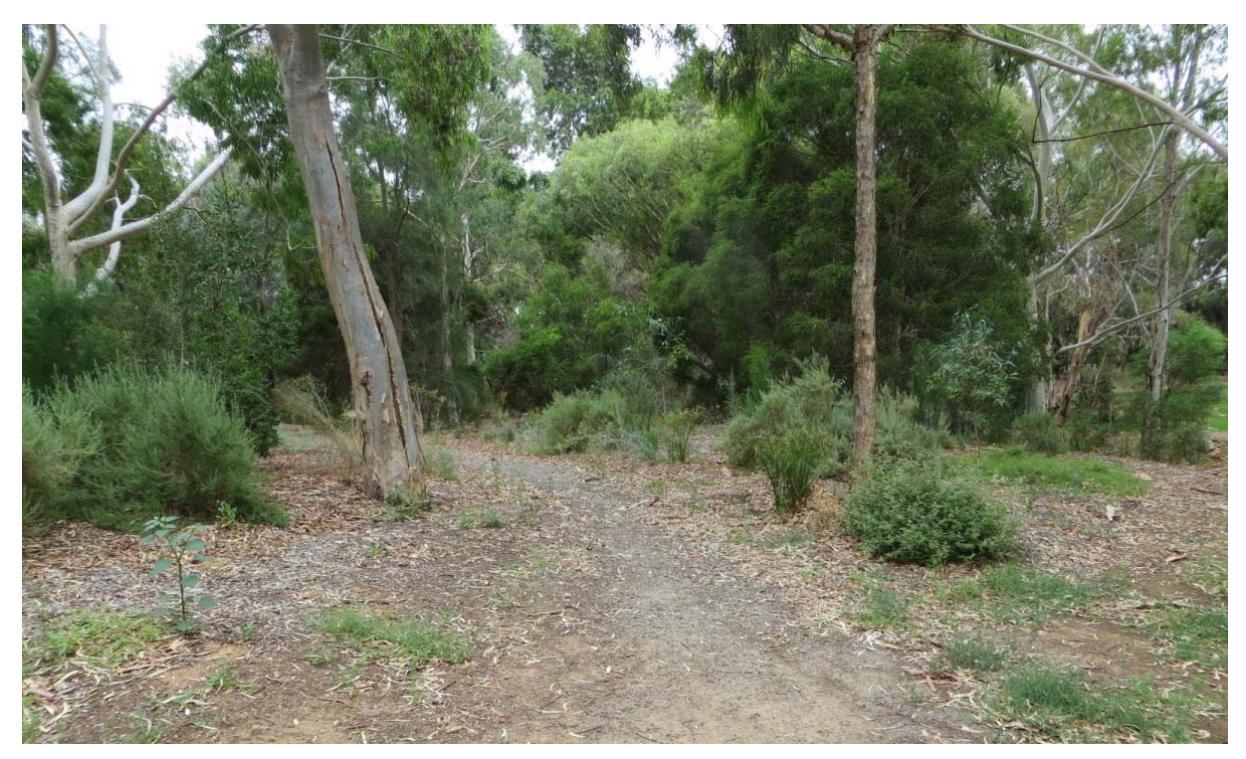
Fifth Creek through the Max Amber Reserve is characterised by wide riparian reserves, and a canopy of mature River Red Gums. The creekline has been revegetated to varying extents along the entire length. Recent plantings have focussed on groundlayer and small shrub species which has greatly increased the diversity of species. Two local native planted species were noted as regenerating naturally, but the number of species regenerating may be higher as regeneration is difficult to distinguish from plantings of grasses and groundcovers. The revegetation area on the south western bank between the tennis courts and the creek (Figure 9) is an excellent example of what can be achieved with revegetation and this area is priority to keep weed free and encourage natural regeneration.

Figure 9 New high diversity understorey plantings amongst older local and non-local revegetation

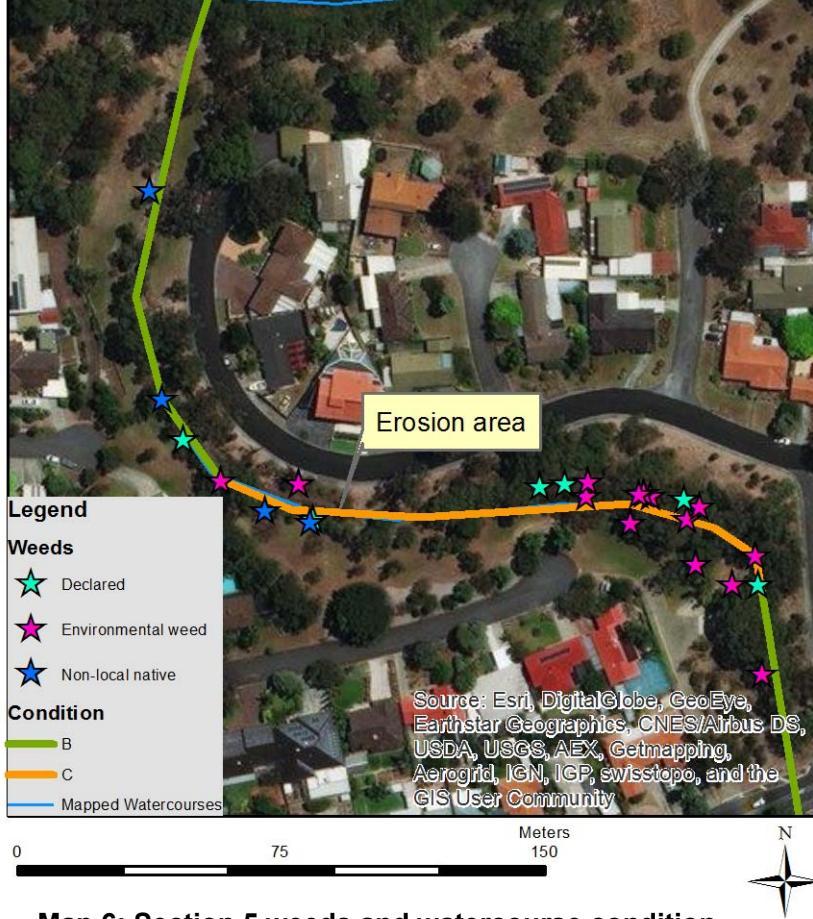
Map 6: Section 5 weeds and watercourse condition

Through the middle part of this section the bed and banks of the creek has eroded (Figure 13). Erosion in this area was noted in the COTMP and so is not entirely the result of the recent floods however the banks appear to be freshly exposed. This area should be assessed by an engineer. Any measures to treat the erosion should combine measures to control bed deepening as a priority and bank erosion where there is a risk to infrastructure. Planting native sedges, rushes and grasses around structures will help to stabilise them.

The most downstream end of the creek has an overstorey of River Red Gums over exotic grasses with few high threat weeds (Figure 14). This would be a good site for future understorey revegetation.
