Third Creek Survey and Management Plan

Report to the Campbelltown City Council

Prepared by Catherine Miles

Miles Environmental Pty Ltd March 2017

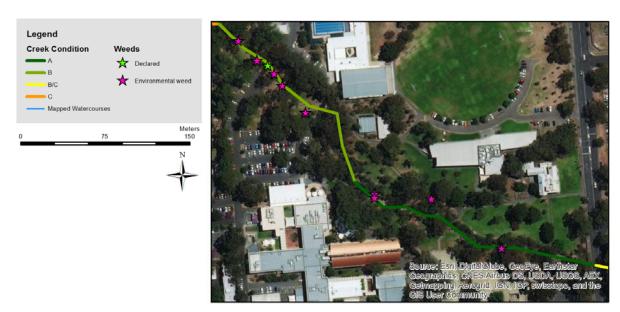
Map 3: Section 2 weeds and watercourse condition

| Feature | Condition |
|---|---|
| Watercourse erosion | Bed deepening and widening downstream of the second footbridge, with instream trees undermined. |
| Channel modification | The top section has been concreted. There is a weir between the first and second footbridge. Some of the lower eroded part appears to have had rock and bank reinforcement in the past that has failed. |

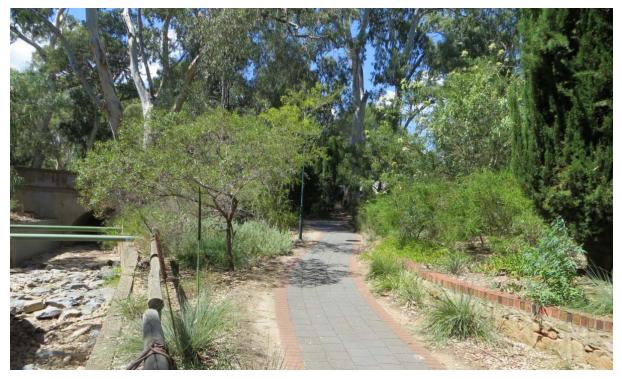
The highest diversity of native species of the entire Third Creek survey was recorded in the Magill Campus, with thirty four species planted in the upper portion (Figure 5) in addition to remnant and regenerated River Red Gums and relatively dense in-stream cover of Stiff Flat-sedge. There are few high threat weeds, although exotic grasses such as Couch, Water Couch and Rice Millet occur on the banks amongst the revegetation (Figure 6).

Figure 5 Area of local native plantings, with 32 local native species recorded, the highest of any section of Third Creek in this survey

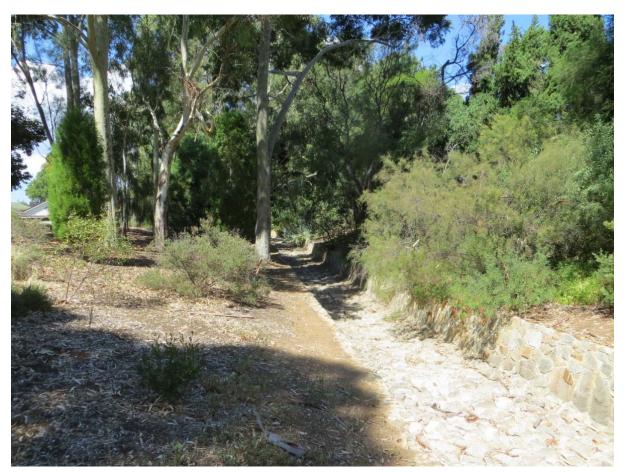
There is limited scope to improve the ecological values of Section 5 due to the narrow riparian widths, garden plantings and the concrete-lining of the channel. A small area adjacent to Glynburn Road could be improved by removing weedy native and non-native species and planting local native groundcovers. Local native species could also be incorporated in the reserve adjacent to Richardson Avenue, as suggested in the COTMP, however this is not considered a high priority site. The soil adjacent to the channel in this area has been eroded recently (Figure 15) and rehabilitation efforts could incorporate local native groundcovers and grasses.

Figure 14 Mixed local and non-local native plantings adjacent to Glynburn Road
